Existing Building Assessment Report

KEG Project 22RS-0193
August 31st, 2022

Project for:
*Promenades East
Condominium Association, Inc.
21405 Olean Boulevard
Port Charlotte, FL 33952*

RE: *Promenades East Existing Condition Survey*
21405 Olean Boulevard, Port Charlotte, FL 33952
KEG File# 22RS-0193

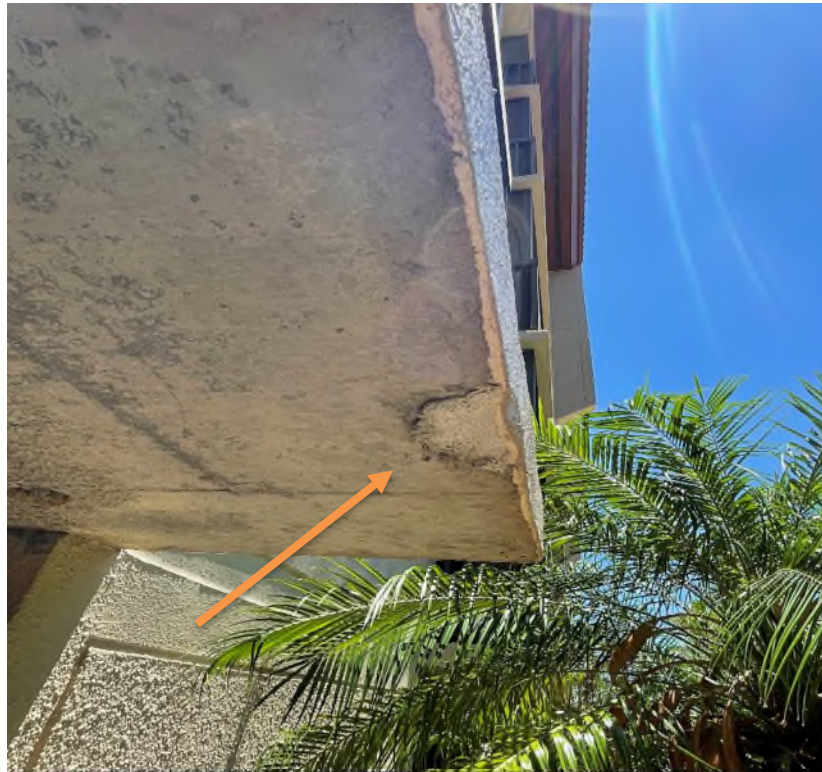
Figure 1 – Spalling at the parking garage ceiling East side near clubhouse

1. The existing deteriorated concrete should be repaired in accordance with International Concrete Restoration Institute (ICRI) industry standards. Areas of concern are located at select unit columns, trash room lintel, windowsills, extruded floor slabs and walkways as indicated above. Continued monitoring of the cracks and spalling should be done until proper repairs have been made.

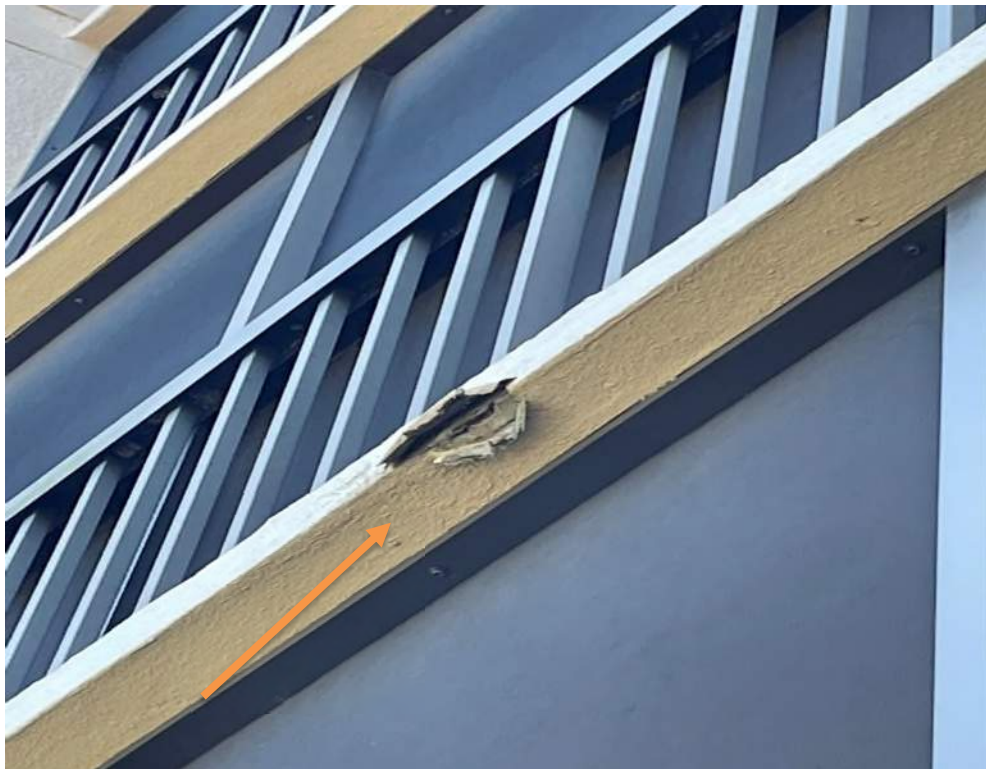
Figure 2 – Spalling on balcony slab edge

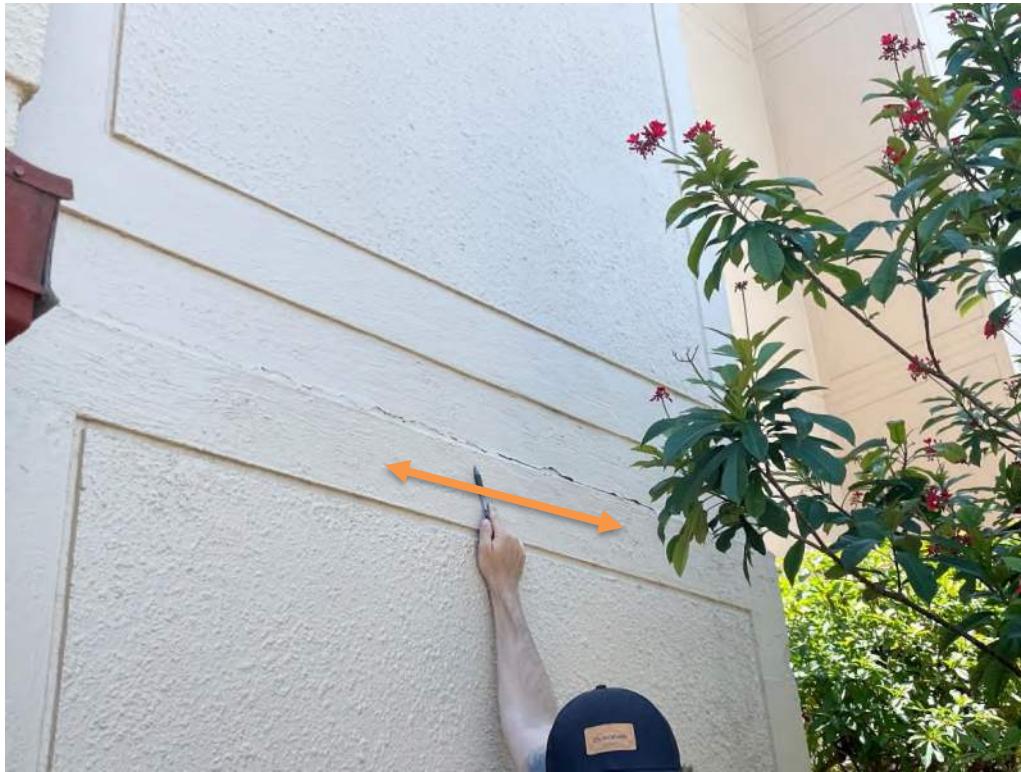
Figure 3 – crack repair needed near front entrance of Promenades East

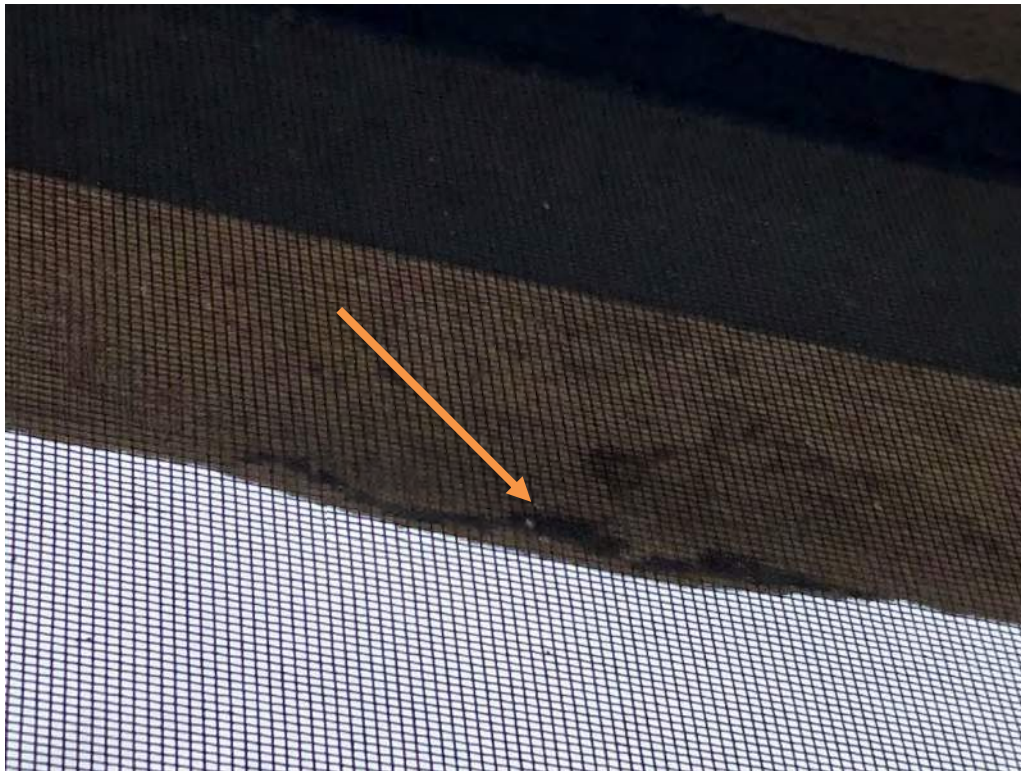
Figure 4 – Concrete spalling observed – Unit 224

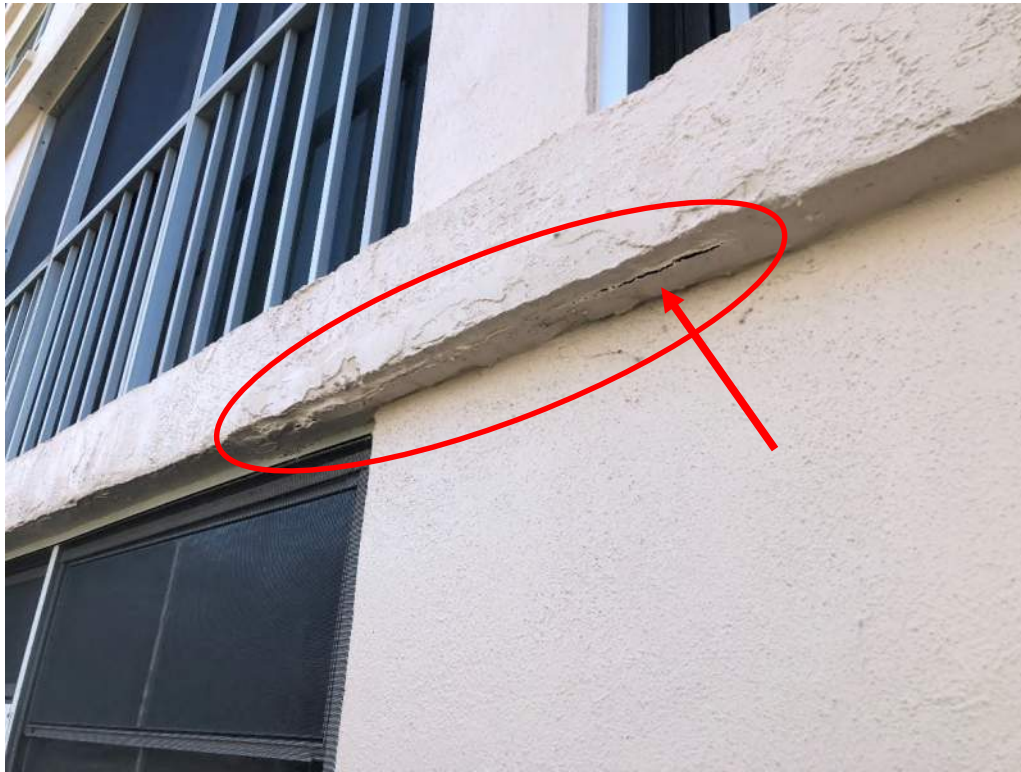
Figure 5 – Spalling on balcony slab edge

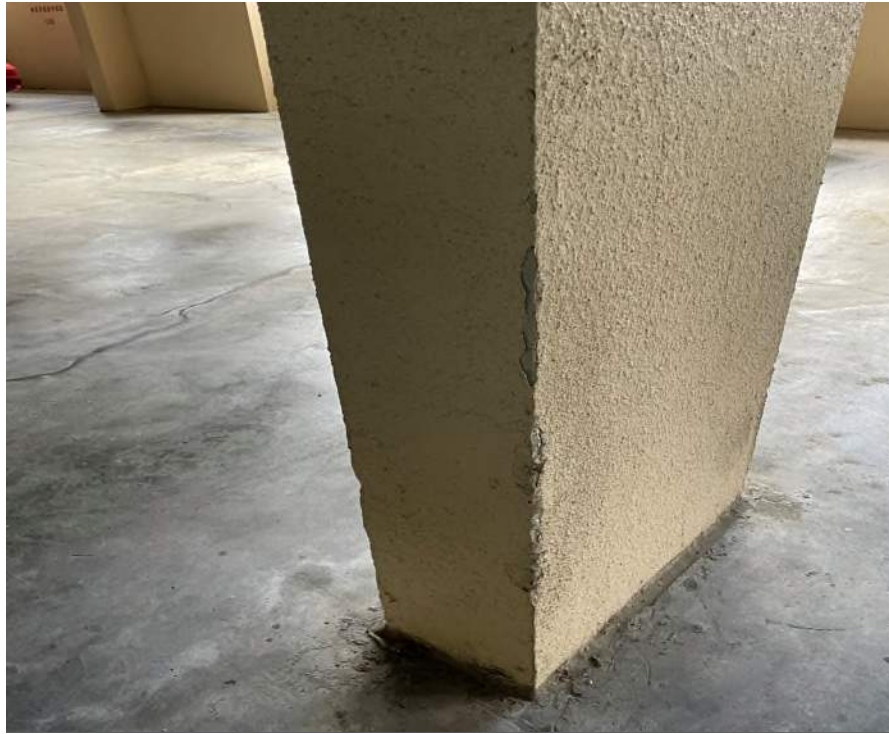
Figure 7 – Stucco delamination identified at exterior column

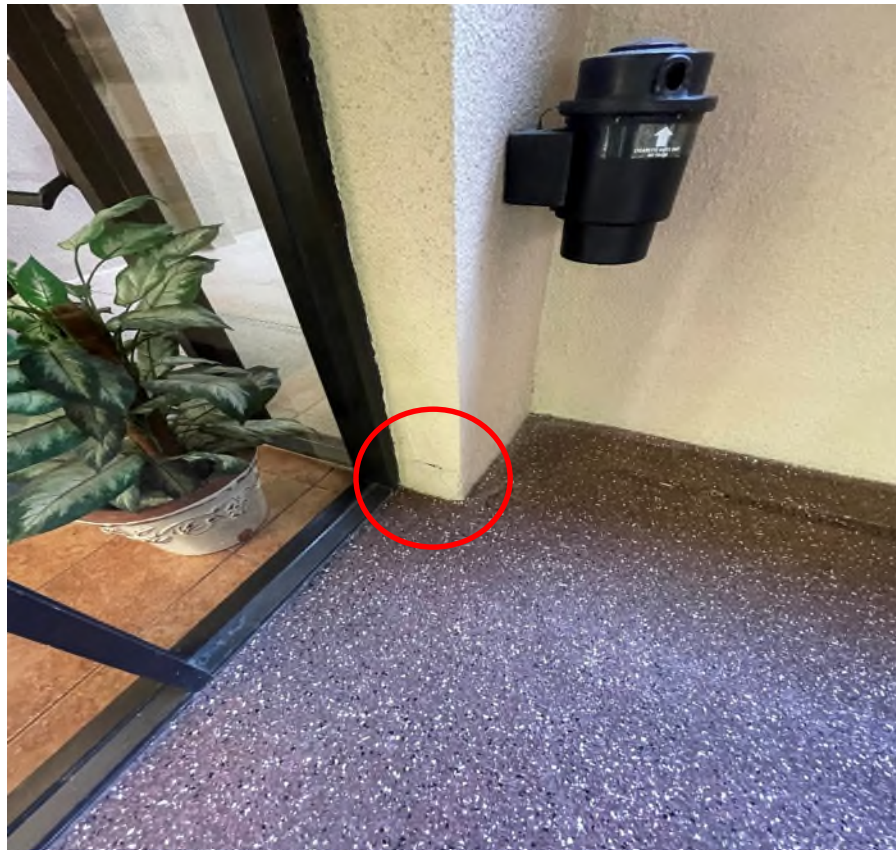
Figure 8 – Identified spalling at column near secure entrance

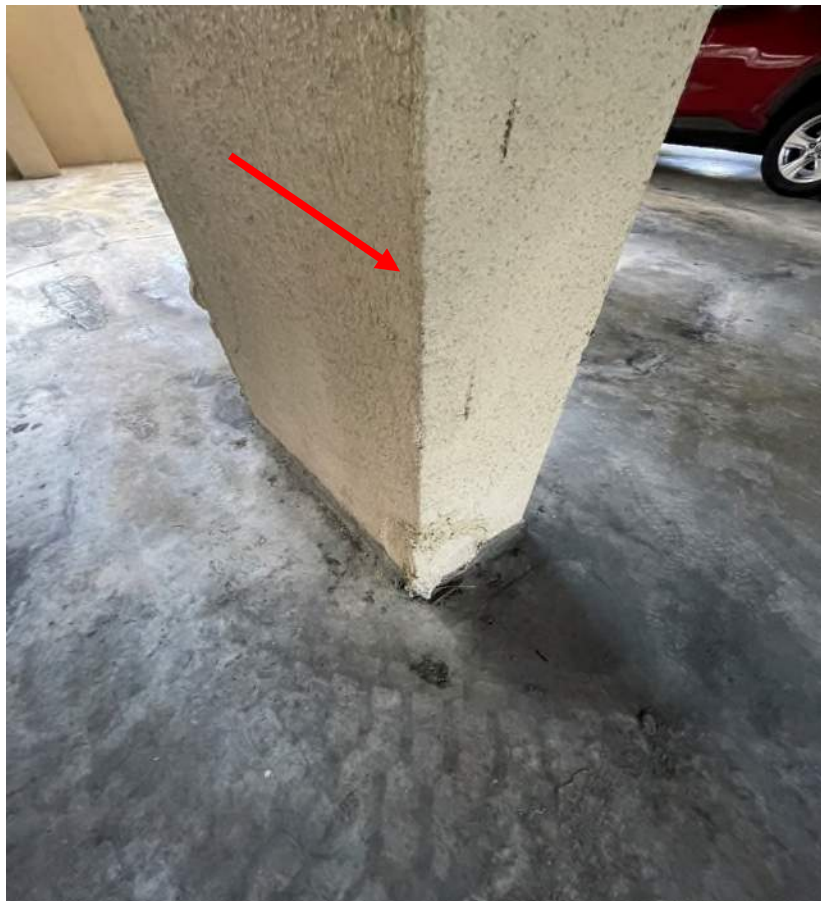
Figure 9 - Identified spalling in parking garage

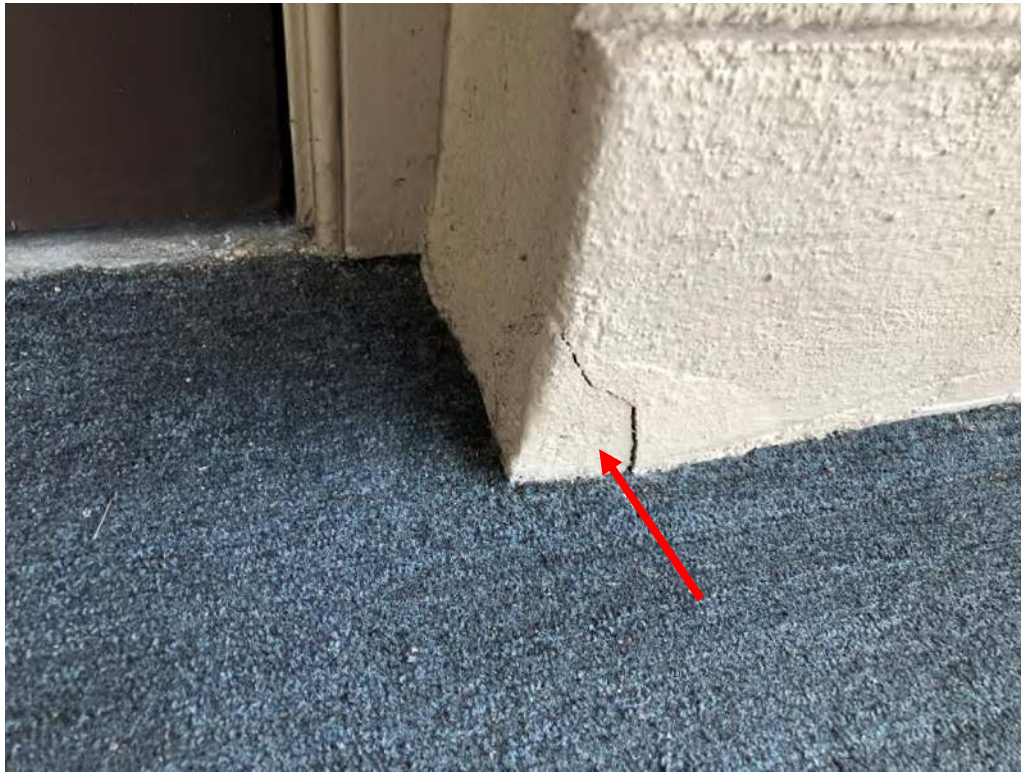
Figure 10 – Stucco crack on balcony wall Unit 533

10. Balconies not evaluated during the inspections are recommended to be further investigated for further signs of cracks and spalls.
 11. KEG recommends sealing all areas where cracks were identified in the areas listed above to prevent water penetrations intruding into the concrete.

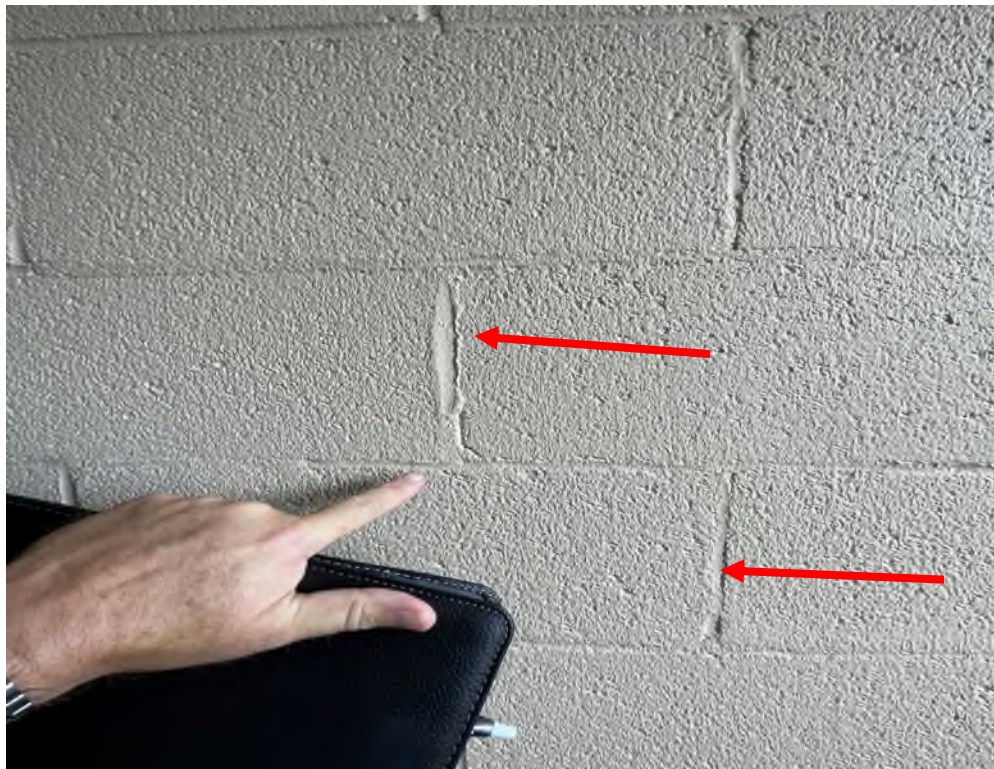
Figure 12 – Identified Stair stepping cracks located in the parking garage. Near Parking Spot 148.

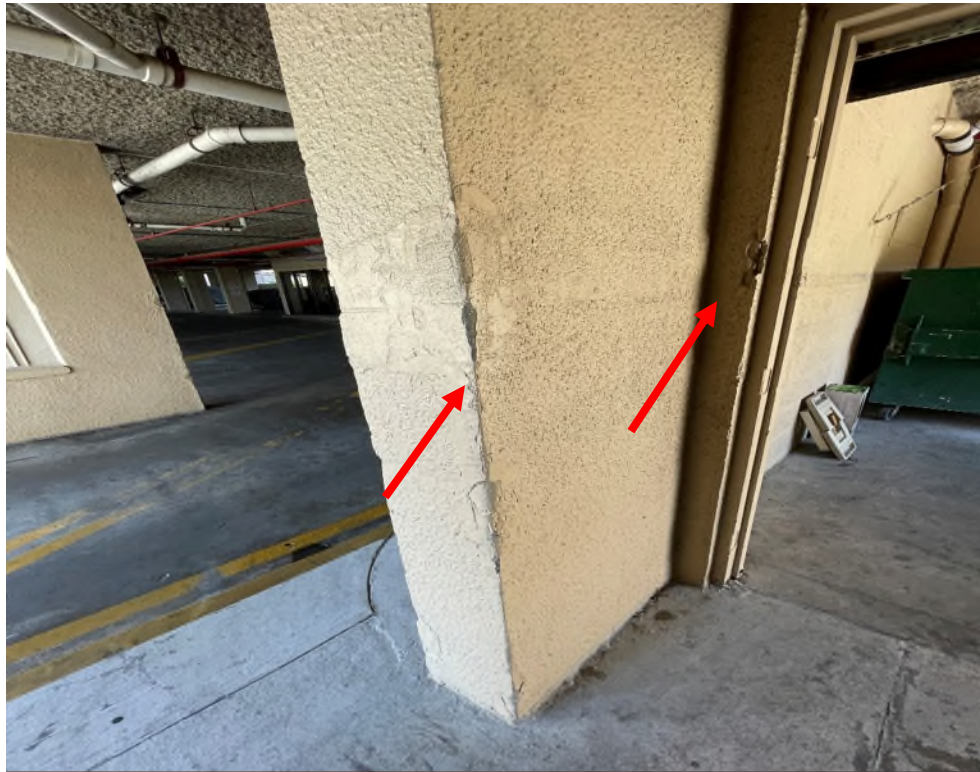
Figure 13 – Existing areas needing repair along the CMU wall located near trash room

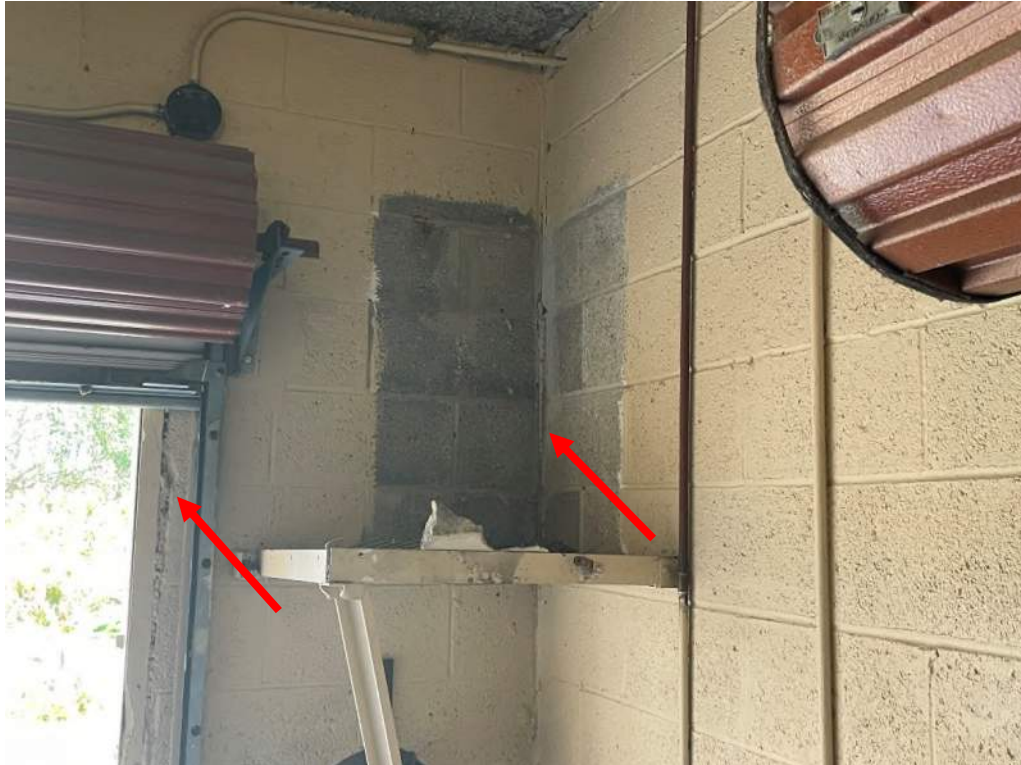
Figure 14 – Cracks and voids identified on the interior walls of the trash room

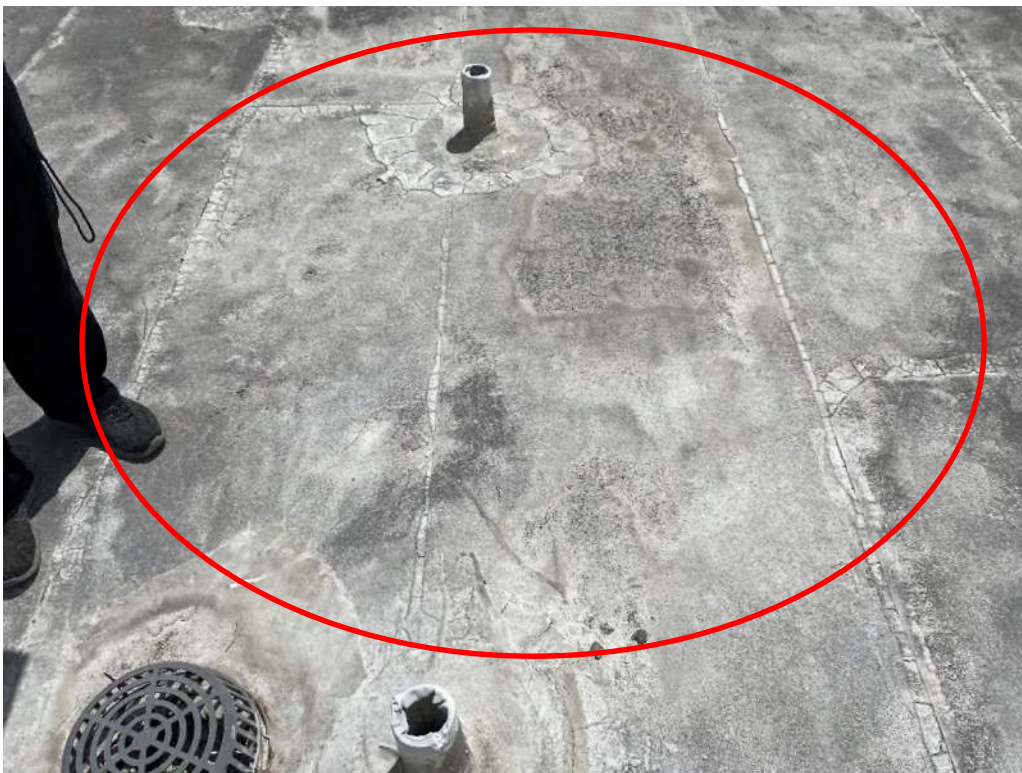
Figure 19 – Roof at end of life – cracks in membrane

3. The current roofing membrane shows signs of ponding at select areas, KEG recommends contacting a roofing contractor to re-slope some sections of the roof to prevent premature breakdown of materials, possible roof leaks, and redirect flow to the drains. This can be accomplished with a reroofing project as KEG recommends a reroofing project within the next few years. Areas where the top and base coat have voids within the polyurethane system should be patched to prevent further intrusions of water.

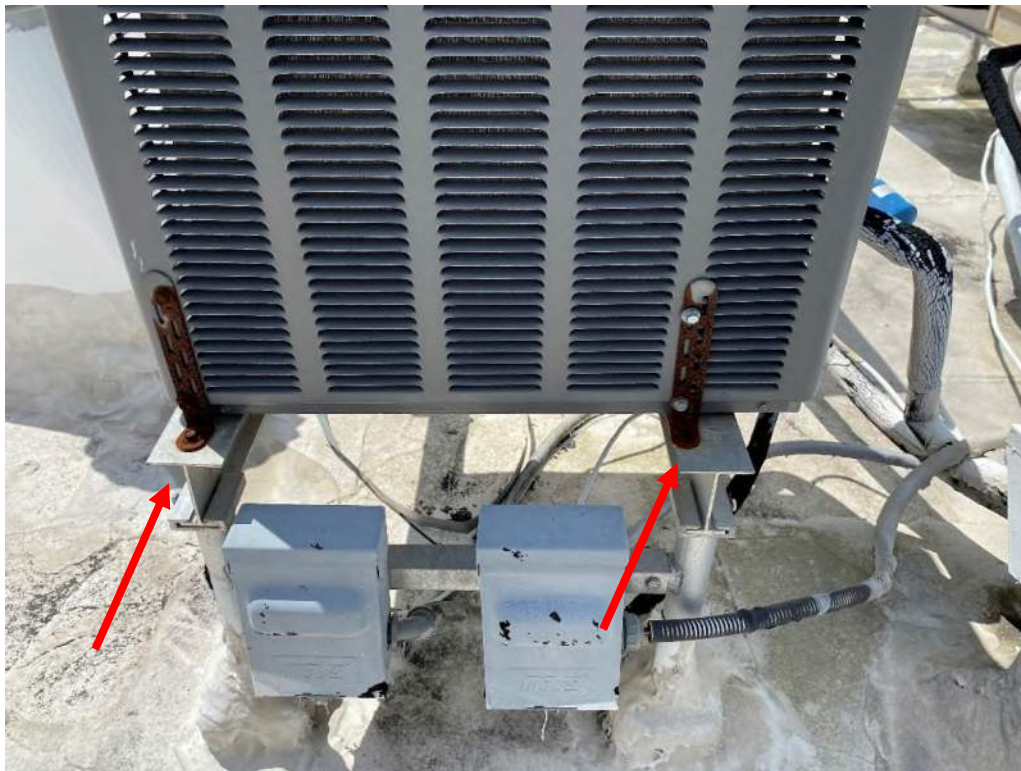
Figure 20 – Typical oxidated A/C tiedowns

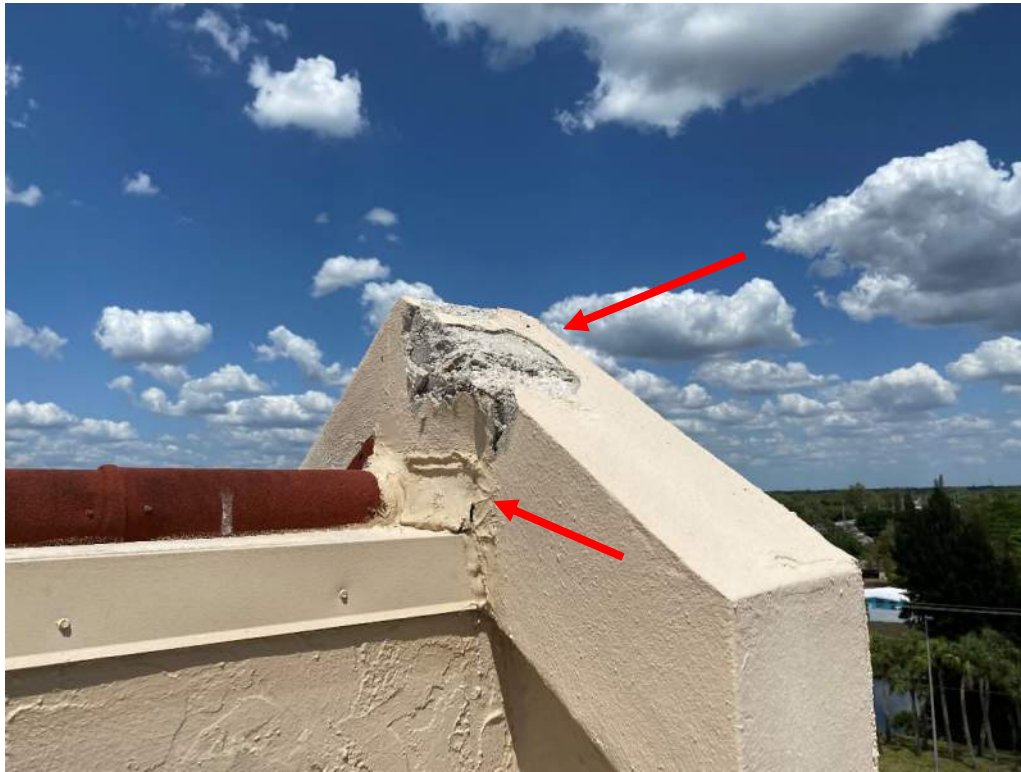
Figure 22 – Damage susceptible to water intrusion

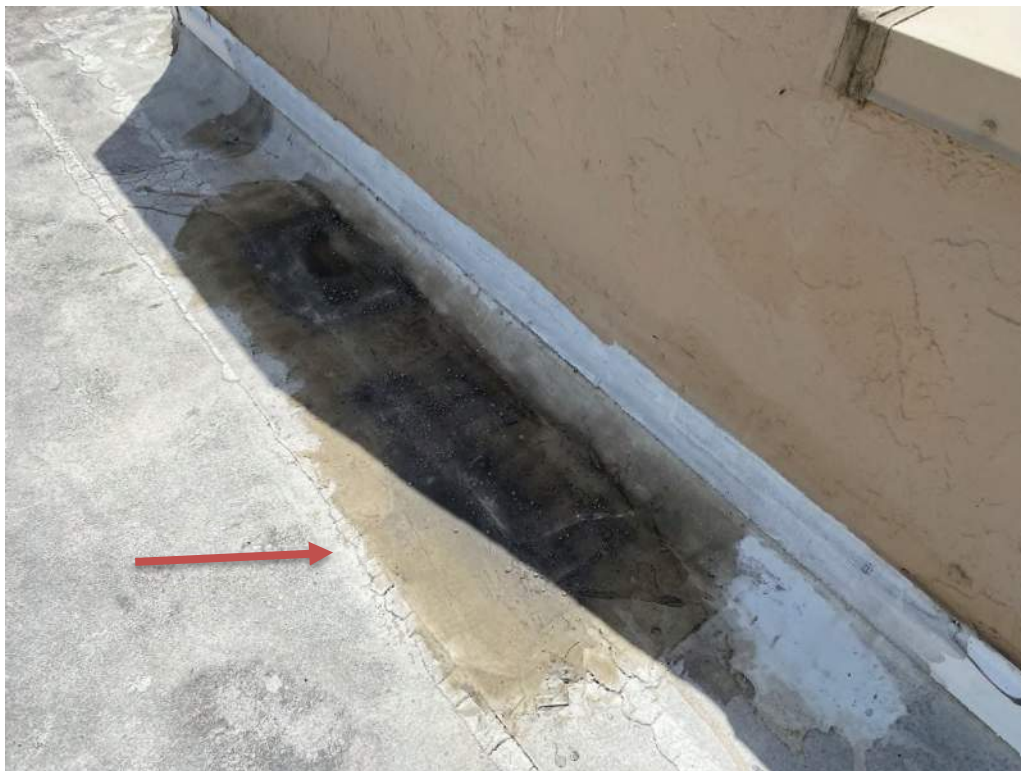
Figure 23 – Evidence of water ponding

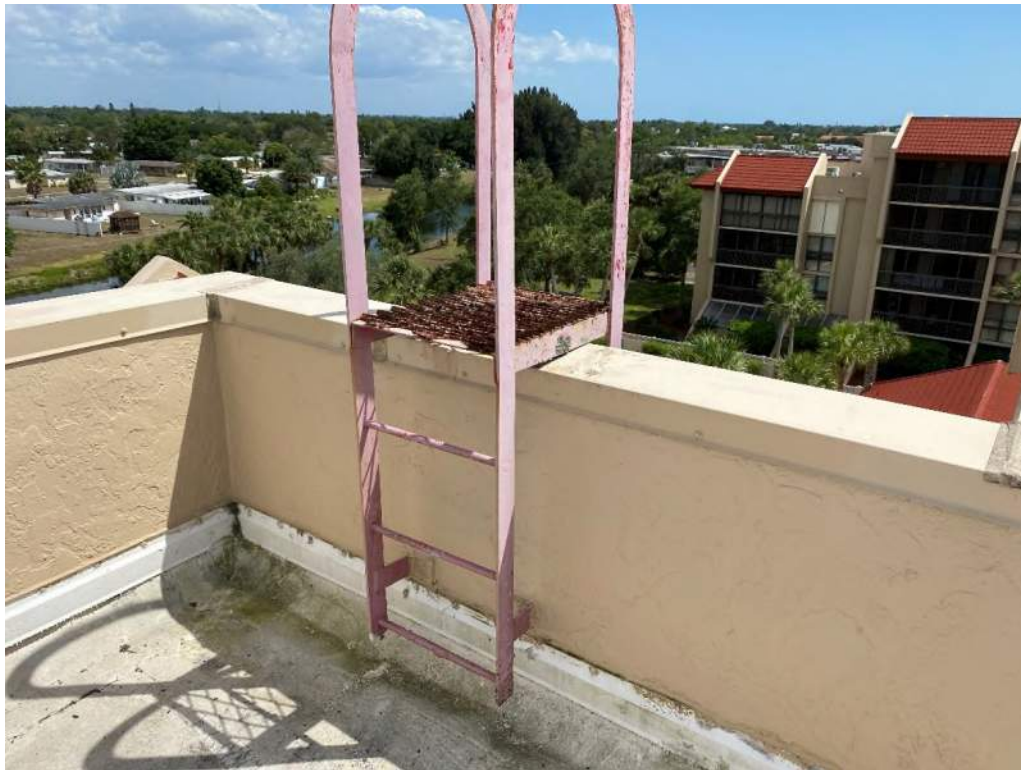
Figure 24 – Existing condition of the steel ladder on the roof

12. The roof top staircase steel decking should be replaced and reapplied with a new protective paint membrane. Sections where railings are observed to be detached should be repaired and recoated. Shoring is recommended to be placed beneath the staircase system until proper repairs.

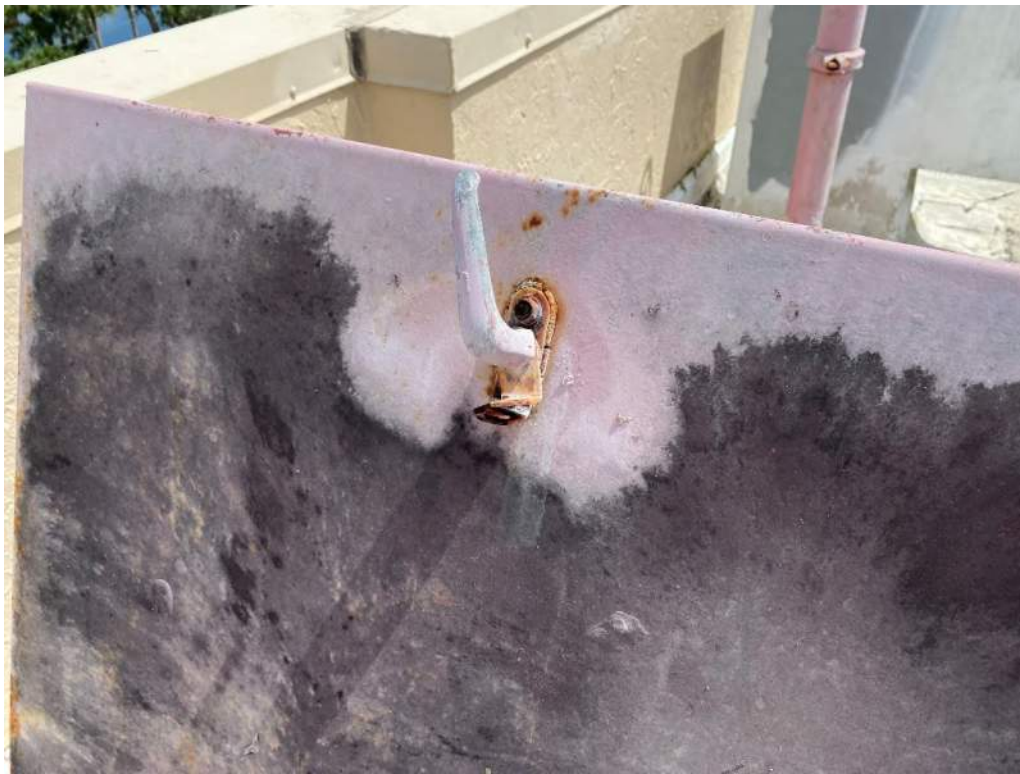
Figure 25 – Corroded Roof access

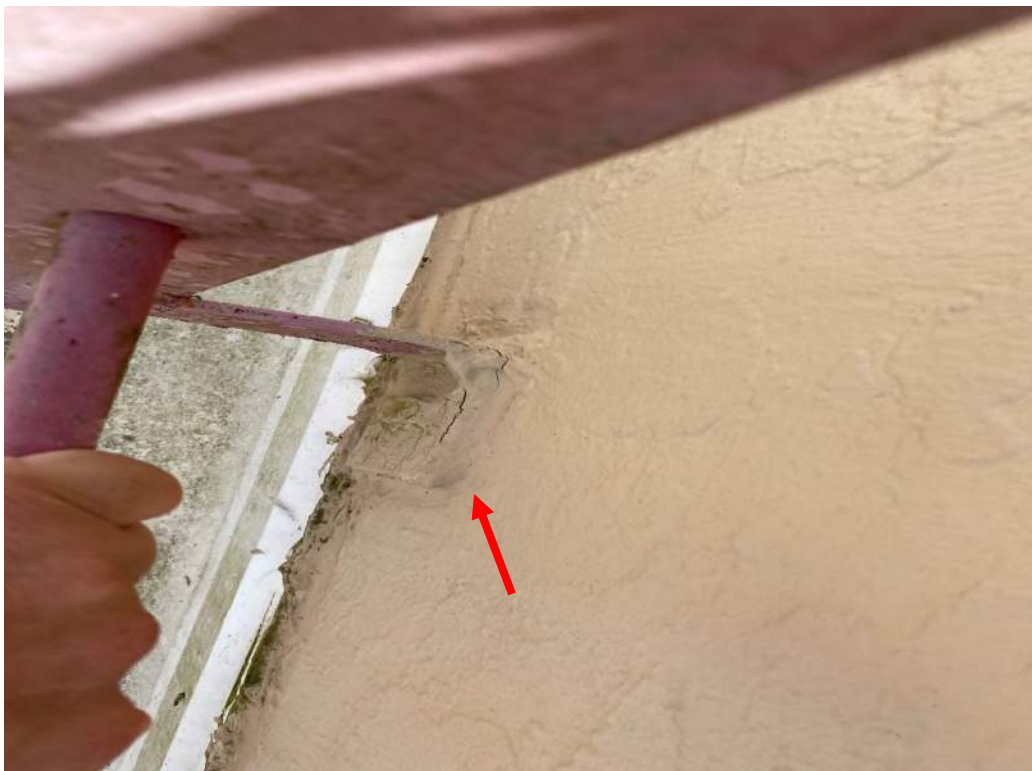
Figure 26 – Mount failing at wall to ladder attachment area

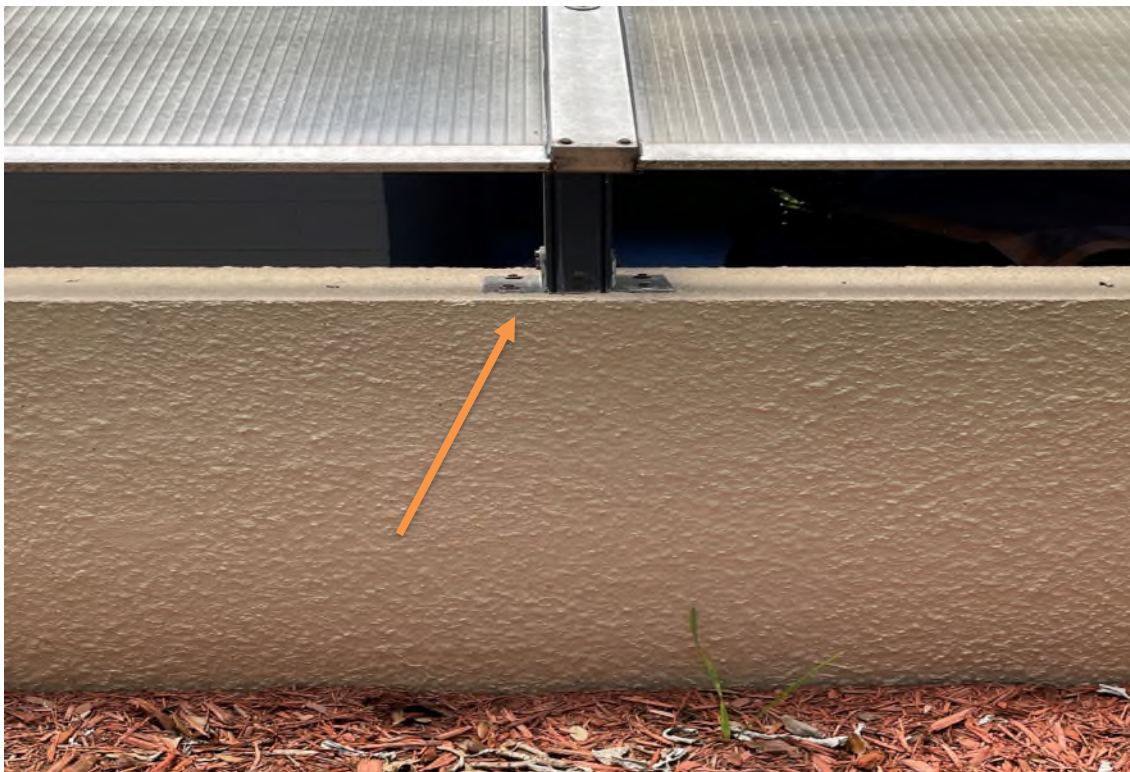
Figure 27 – Evidence of water intrusion at unsealed corroded fasteners on exterior wall of parking garage

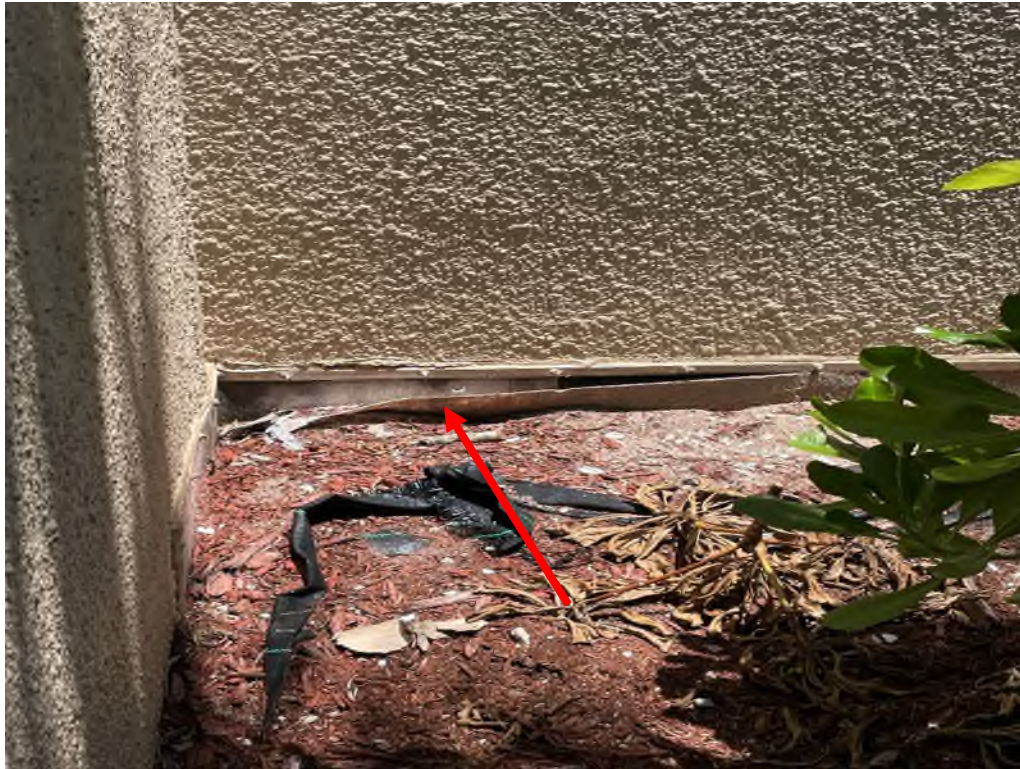
Figure 28 – Possible moisture issue

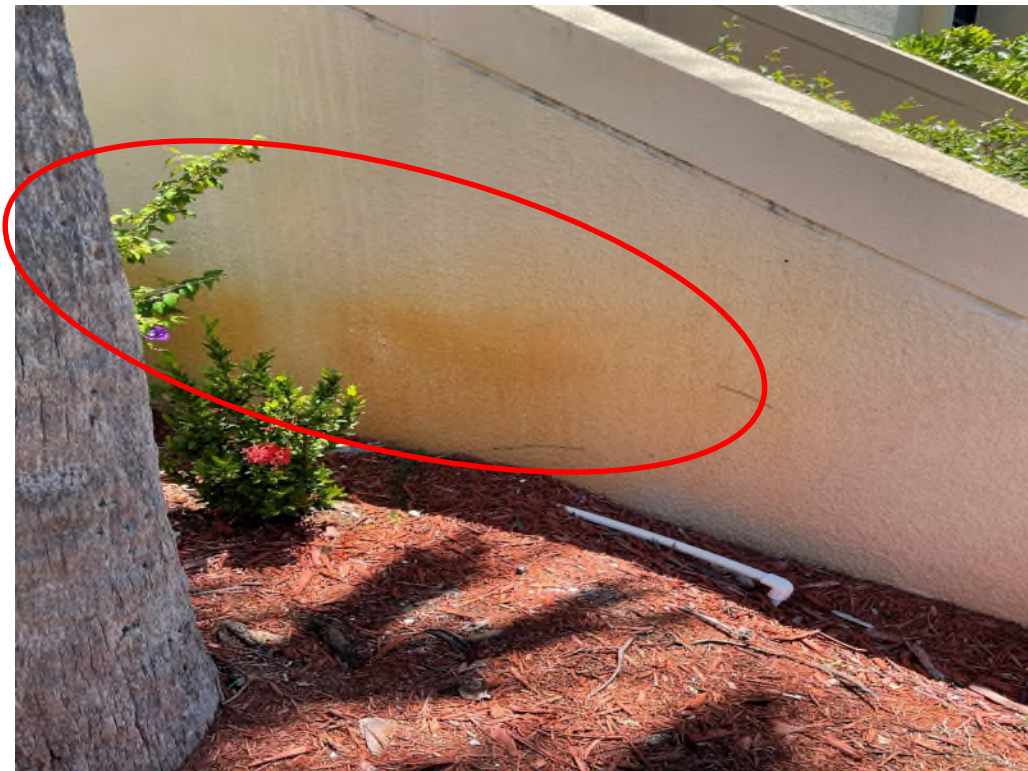
Figure 29 – Paint discoloration due to constant water exposure

8. Remove and replace any sprinkler systems away from the building envelope to avoid constant water contact. Continued water contact can accelerate the breakdown of materials.

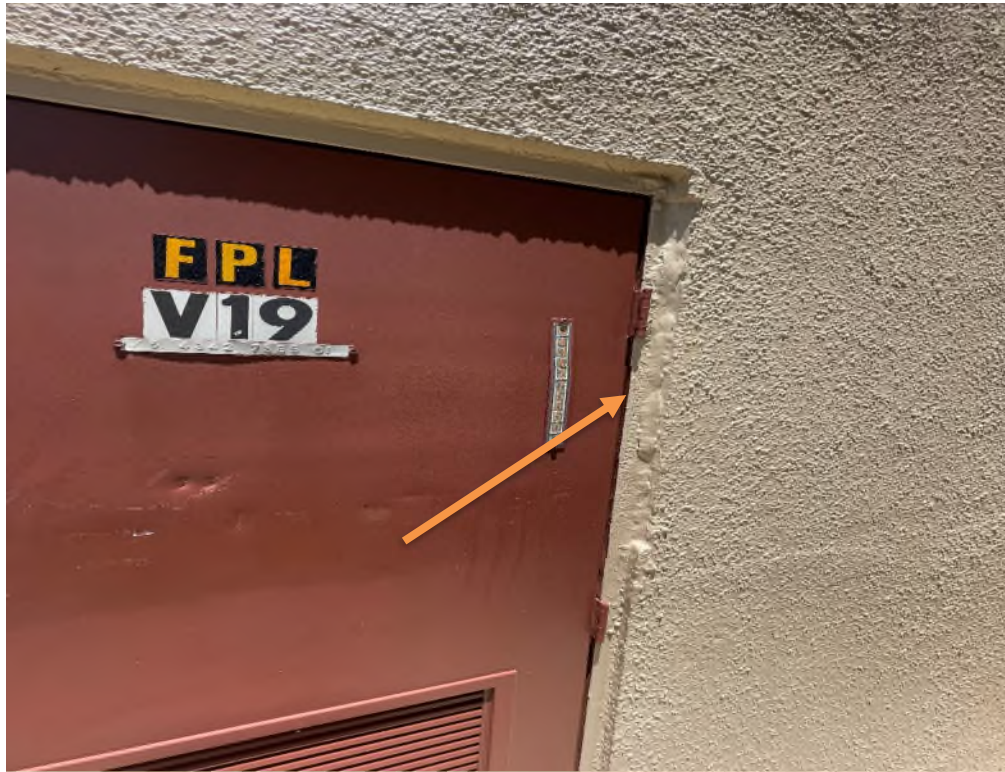
Figure 31 – Failed sealant along exterior door

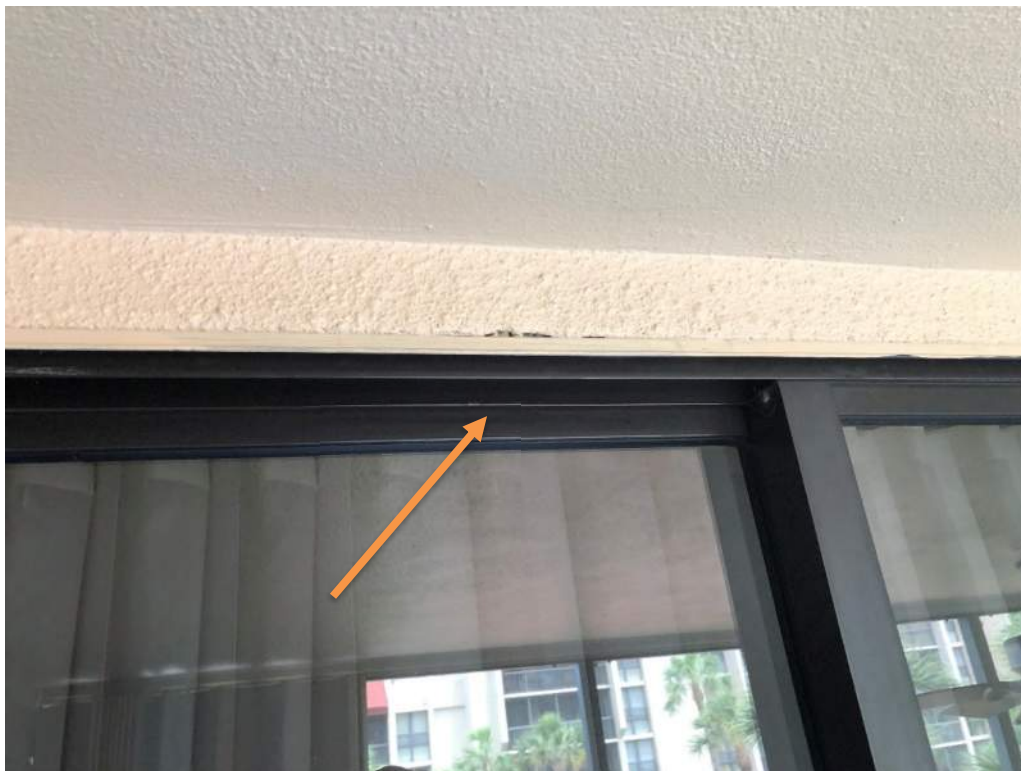
Figure 32 – Failed sealant or lack of sealant around sliding glass doors

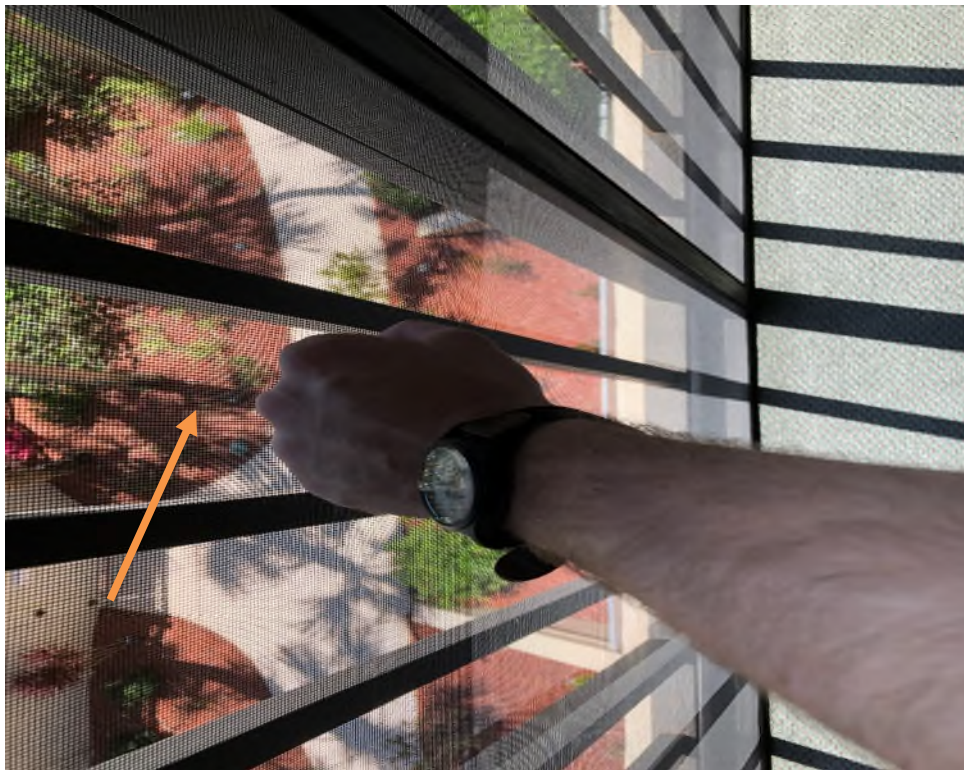
Railings that were accessed were tested for stability and could withstand a manual load. The existing railing conditions do not meet current Florida Building Code (FBC), which requires the railings to be 42 inches above finished floor (Meets Code) and have picket spacings no greater than 4-inches apart (Does not meet code). The association is “grandfathered in” as it pertains to their railings due to the original design emplaced, but in the event these railings are replaced, they will have to meet the current FBC.

Figure 34 – Picture depicting the relative length between pickets being larger than 4 inches

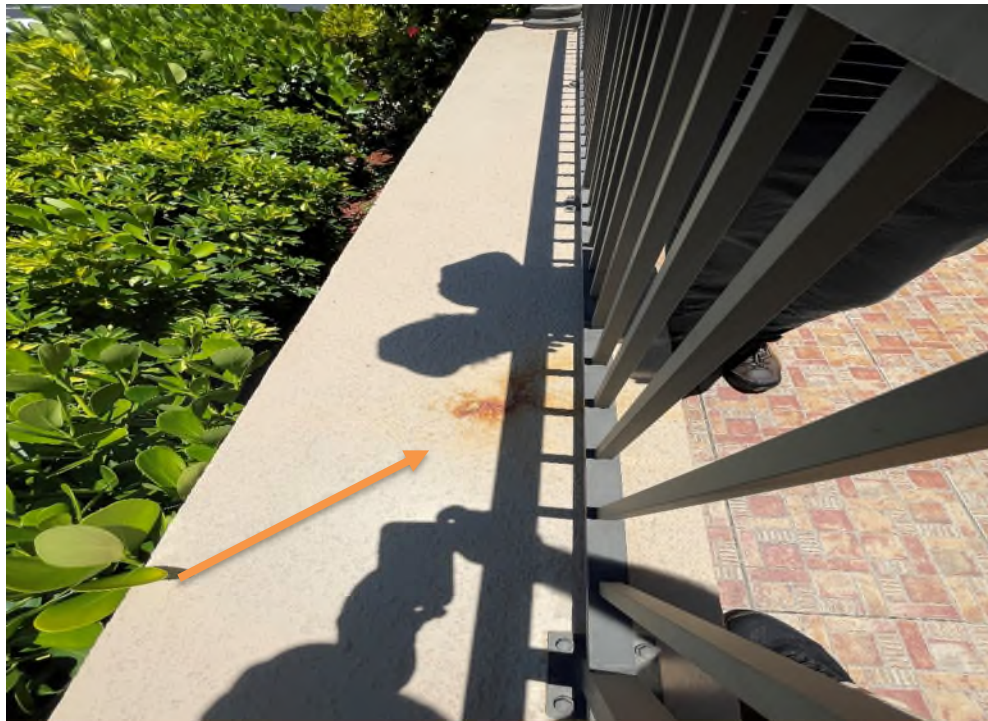
Figure 35 – Possible corrosion on railing system – staining of wall under front entrance railing system.

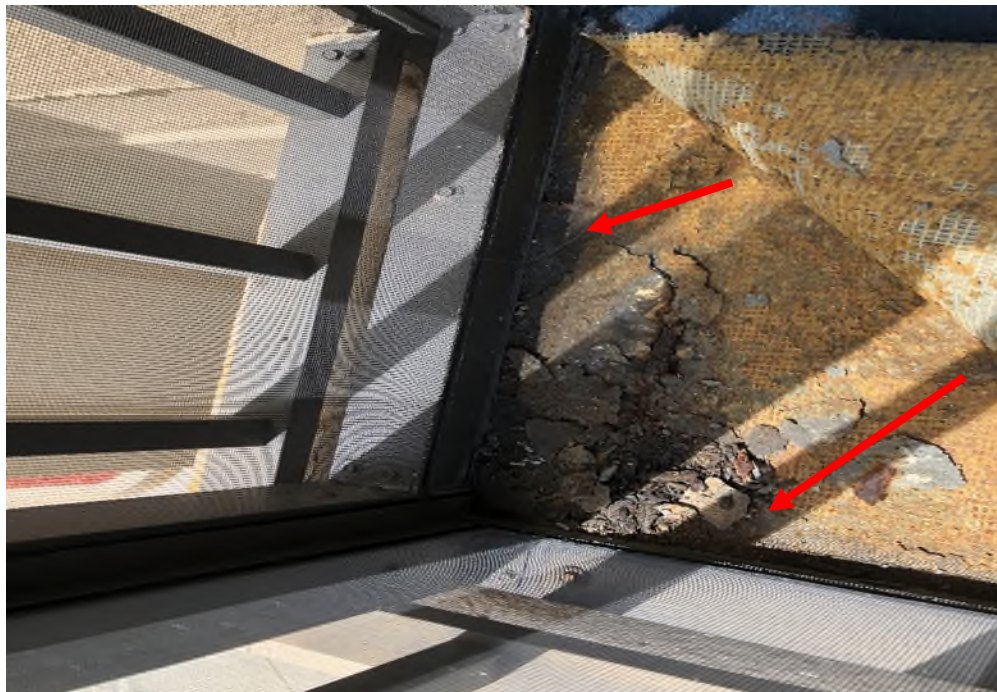
Figure 36 – Deterioration – Railing to Balcony Slab – Unit 309

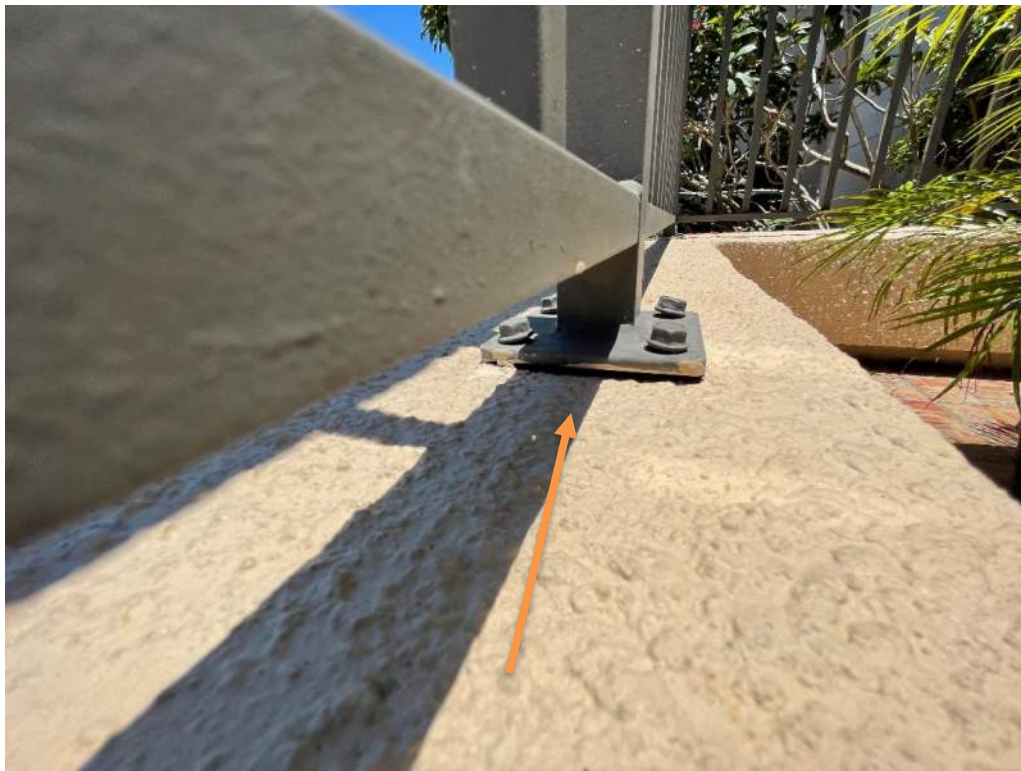
Figure 37 – Fasteners not fully seated on front entrance railings

13. KEG recommends repairing areas where the front entrance railings are found to be unstable immediately to avoid potential fall hazards.
 14. KEG recommends adding additional drainage vents along the rooftops to help extrude water build up on the roof tops.
