Existing Building Assessment Report

KEG Project 22RS-0193
August 31st, 2022

Project for:
*Promenades East
Condominium Association, Inc.
21405 Olean Boulevard
Port Charlotte, FL 33952*

RE: *Promenades East Existing Condition Survey*
21405 Olean Boulevard, Port Charlotte, FL 33952
KEG File# 22RS-0193

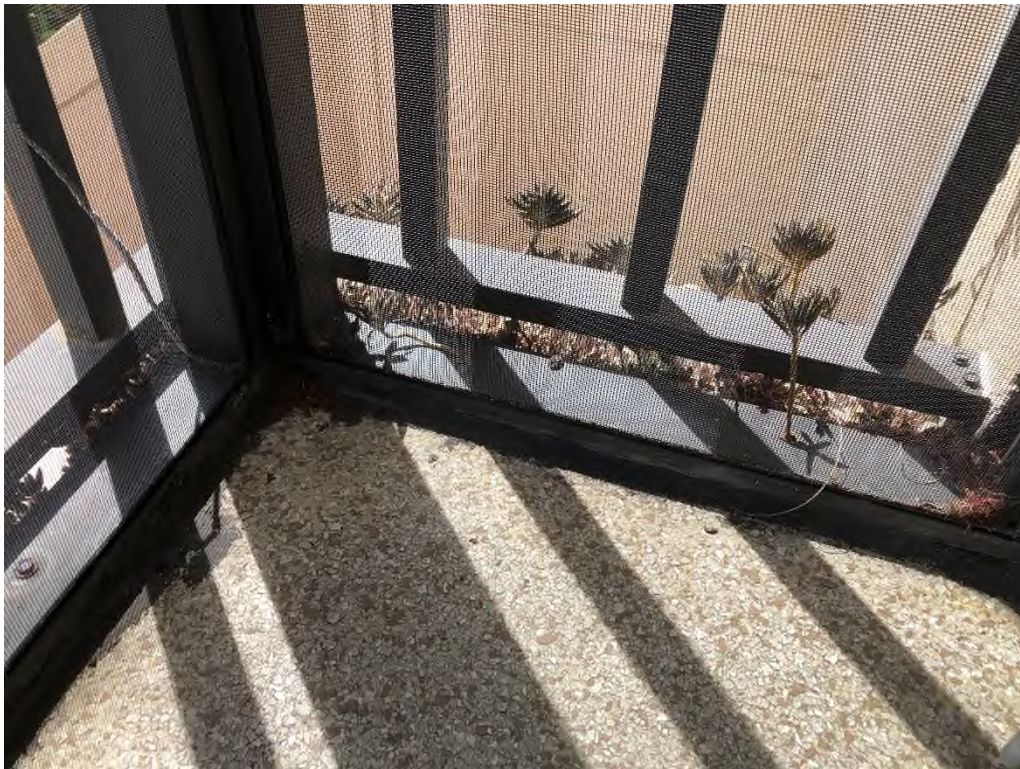
Figure 39 – Plant growth on balcony deck and through railing system - Unit 226

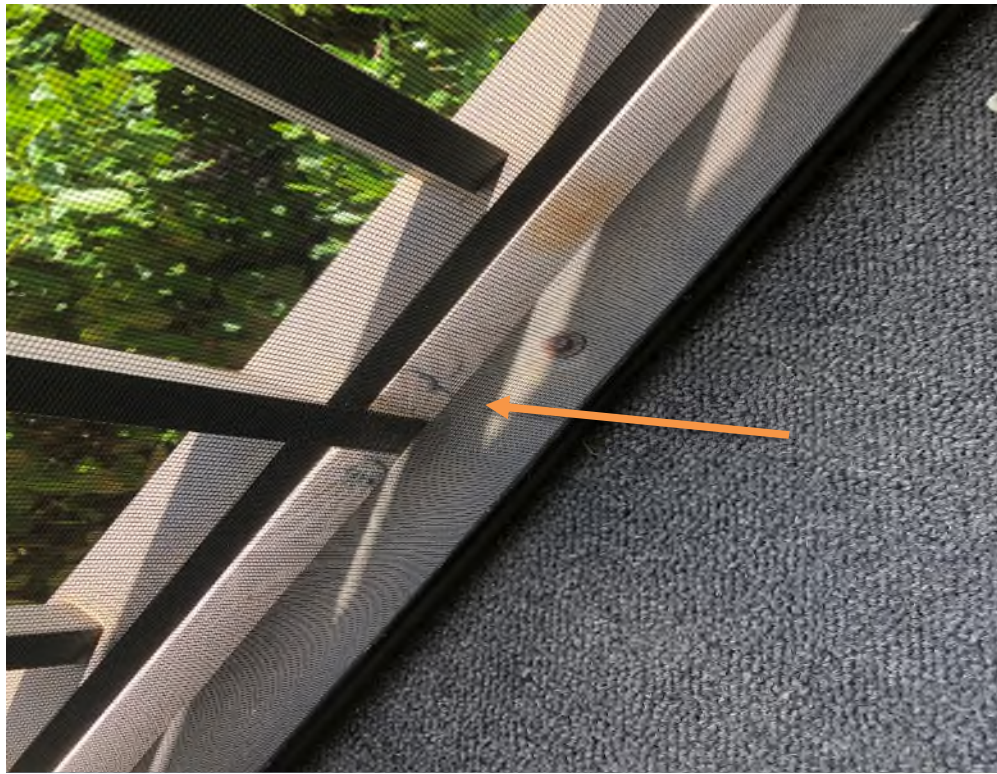
Figure 40 – Railing Post Pocket damage - Unit 214

2. The balconies are recommended to undergo further investigation during the resurfacing project to identify if concrete repairs are needed at locations where cracks, delamination, or post pocket spalling has occurred.

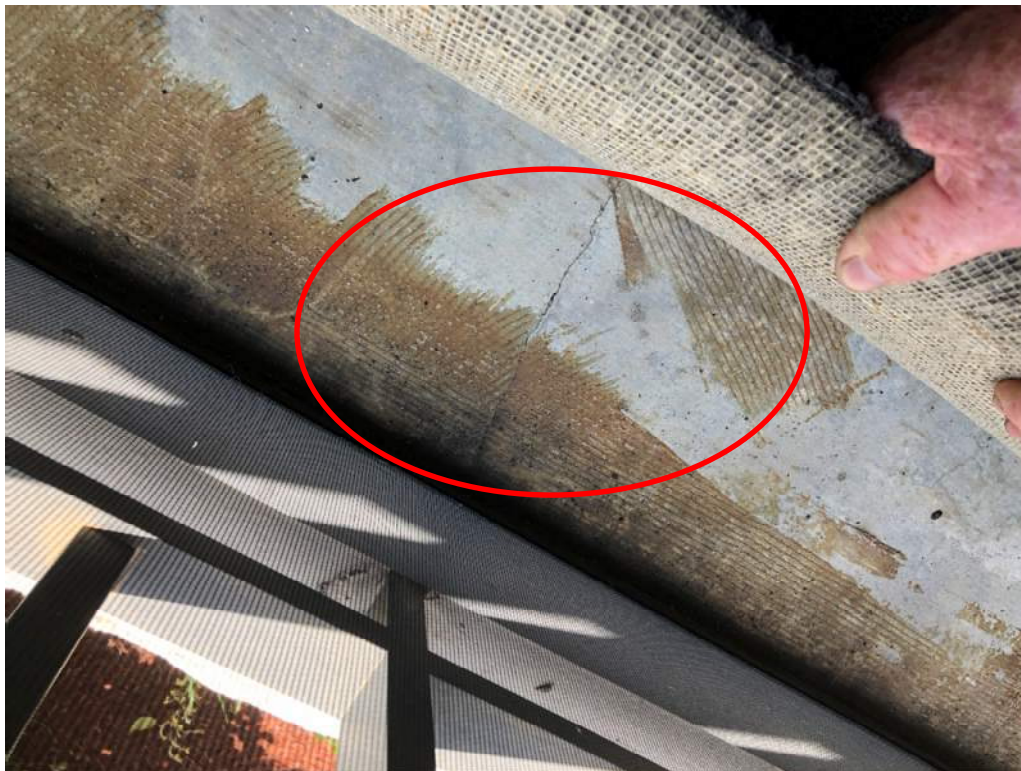
Figure 41 – Typical crack in balcony slab - Unit 214

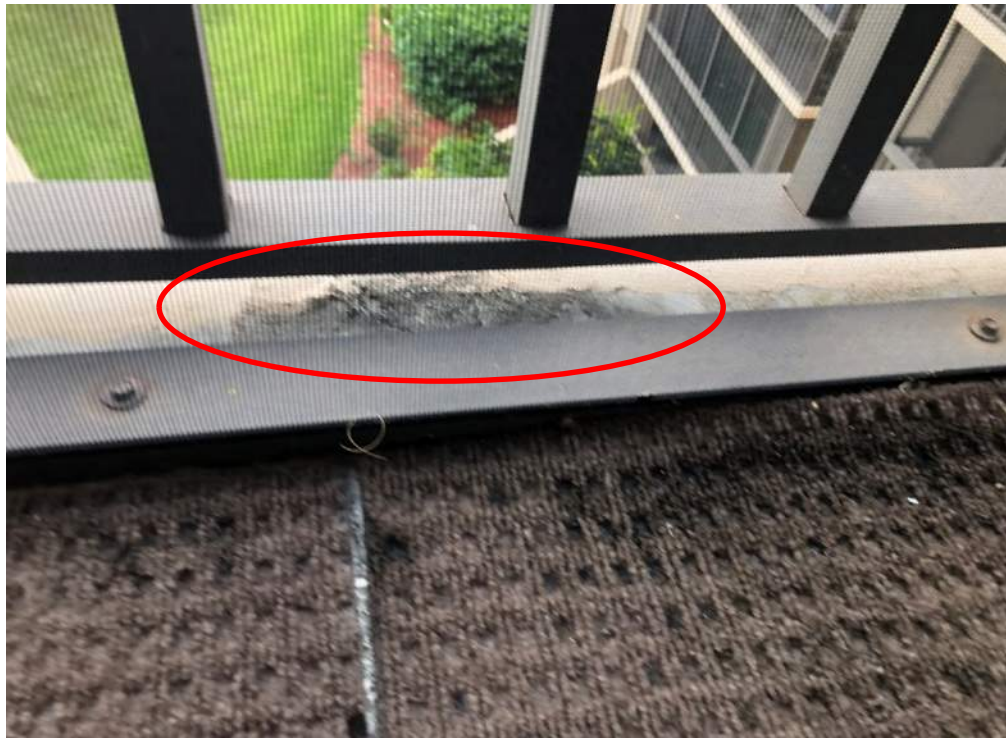
Figure 42 – Typical coating delamination at balcony slab edge under railings - Unit 512

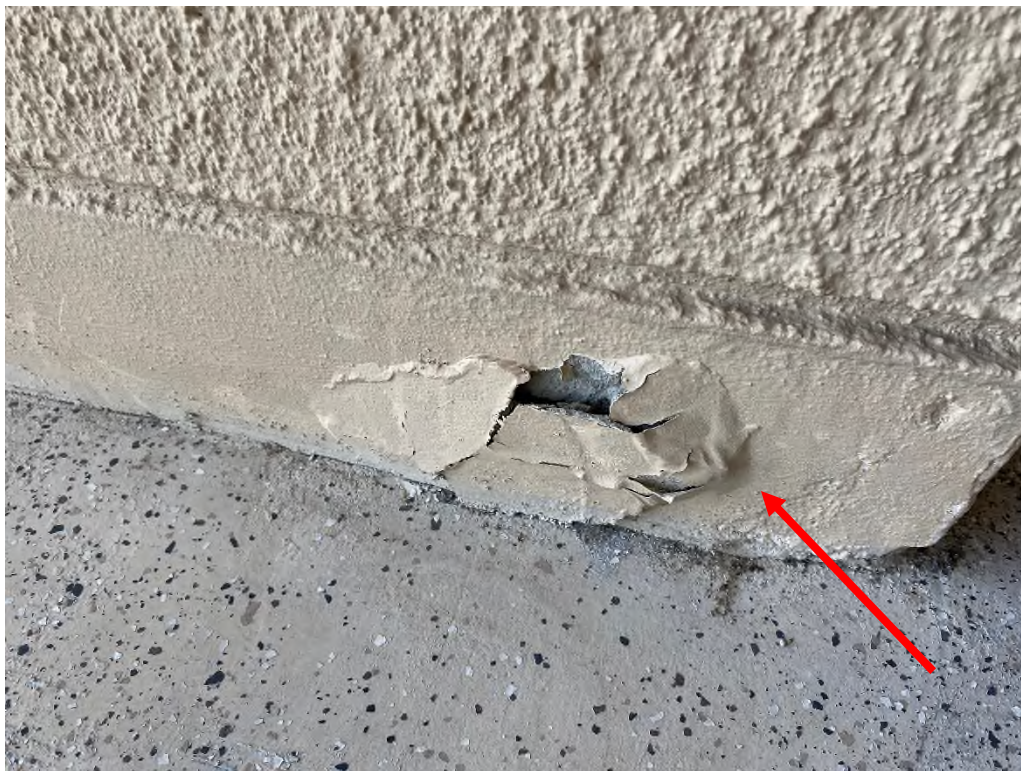
Figure 43 – Delaminated area of wall - Unit 612

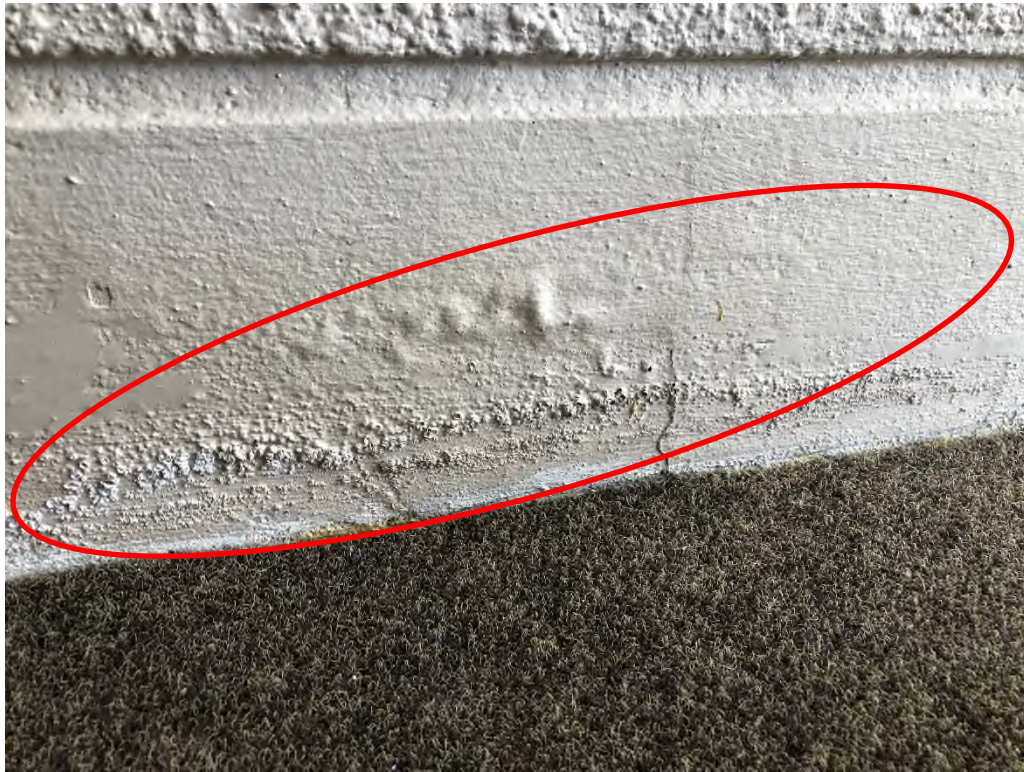
Figure 44 – Deterioration observed along balcony wall - Unit 5

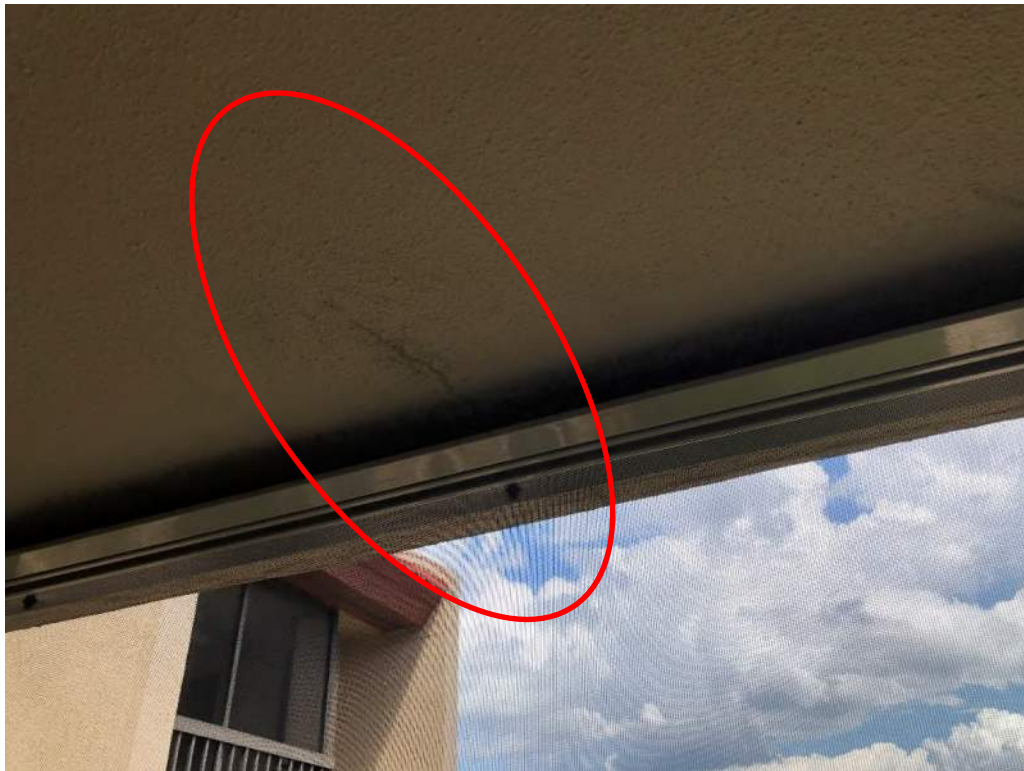
Figure 45 – Spalling located along the overhead floor slab - Unit 516

- In the event where concrete deterioration is evident at a balcony, KEG recommends repairing the area following International Concrete Repair Institute (ICRI) guidelines. This is when the association should implement a liquid applied waterproofing membrane in lieu of the tile finish or outdoor carpet where applicable.

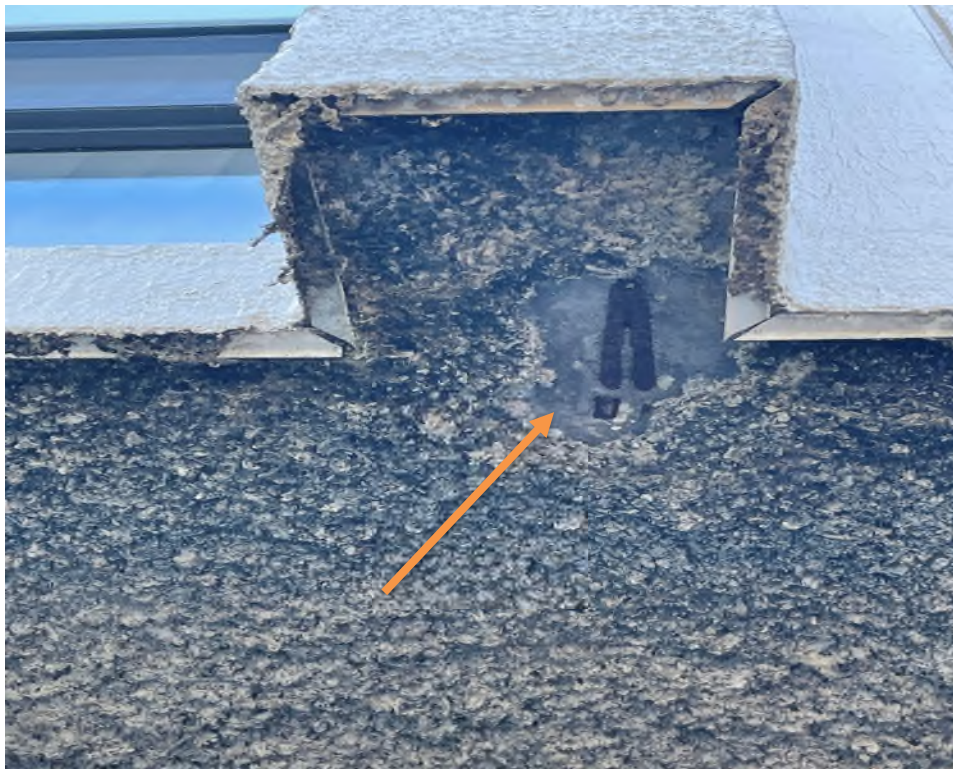
Figure 46 – Stucco delamination and exposed rebar found at the North Entrance

1. The existing deteriorated concrete should be repaired in accordance with International Concrete Restoration Institute (ICRI) industry standards. Areas of concern are located at select unit columns, trash room lintel, windowsills, extruded floor slabs and walkways as indicated above. Continued monitoring of the cracks and spalling should be done until proper repairs have been made.

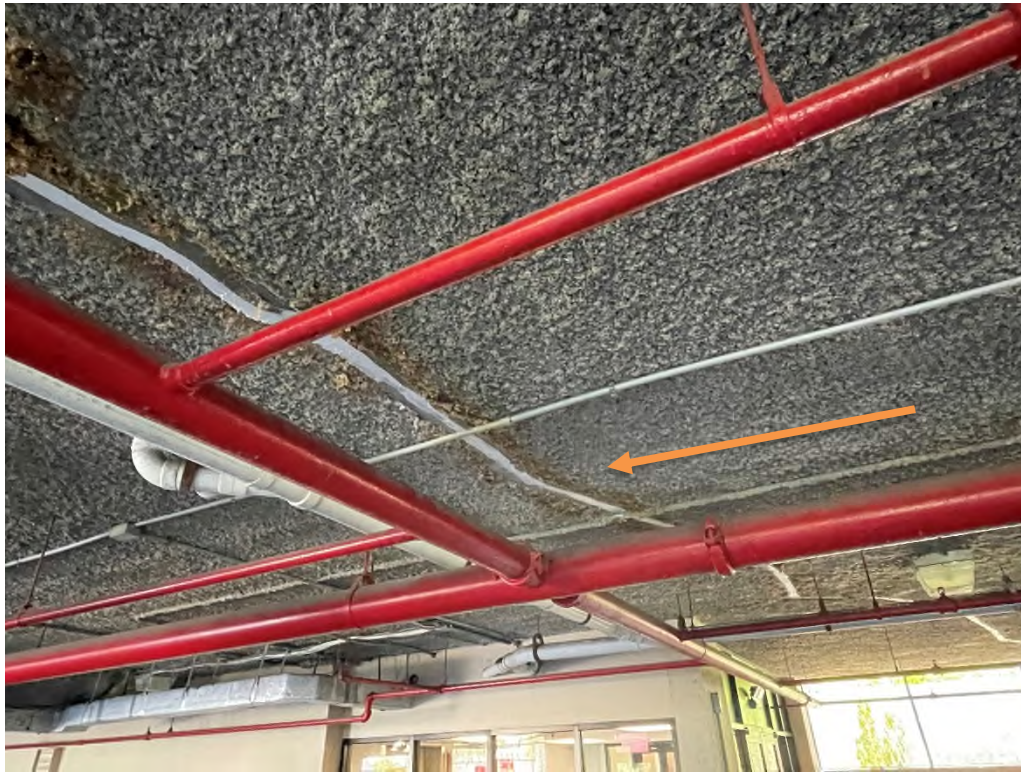
Figure 47 – Repair in progress on parking garage ceiling

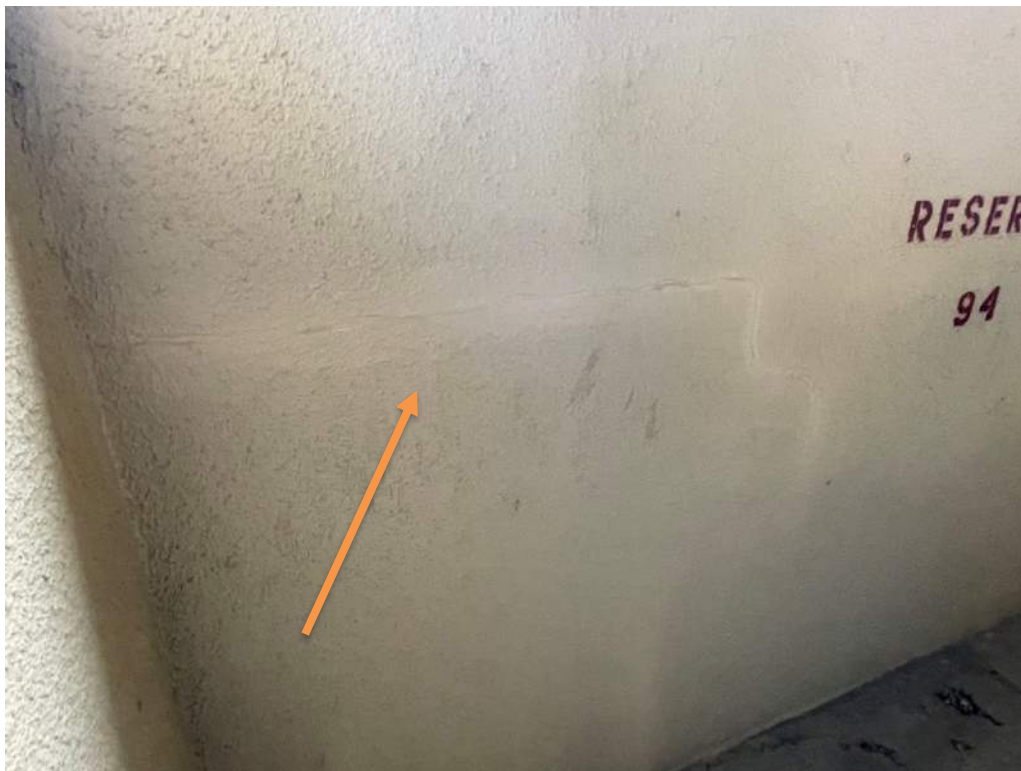
Figure 48 – Typical stair step cracking on parking garage wall

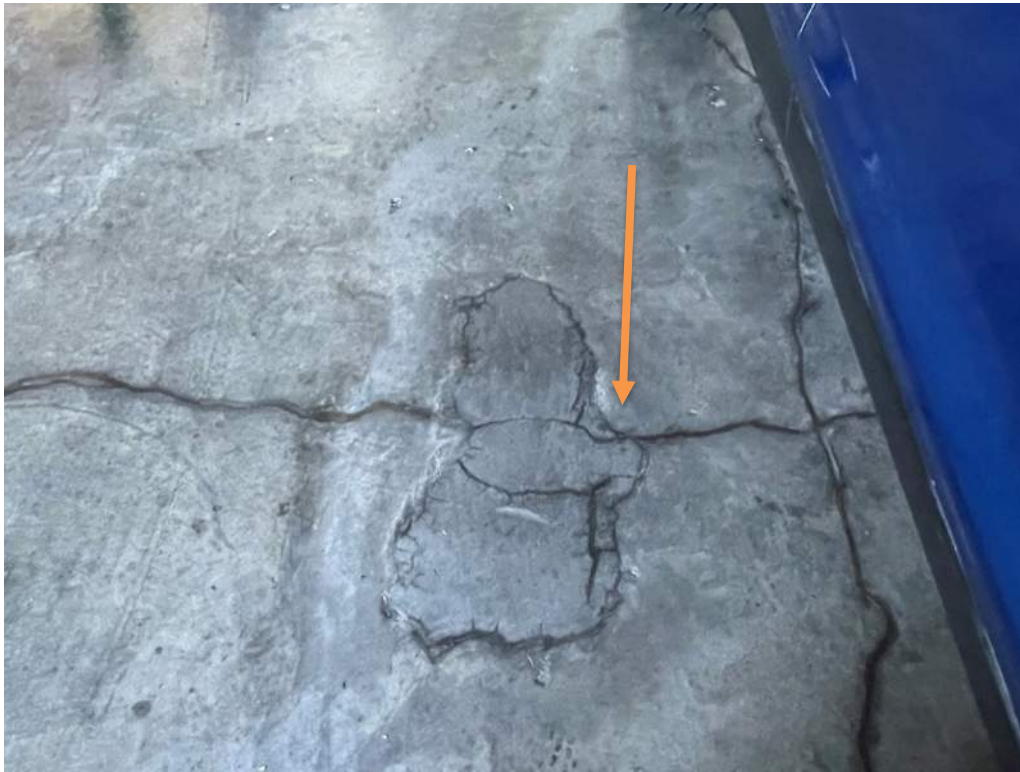
Figure 49 – Parking garage slab cracks and typical previous repair

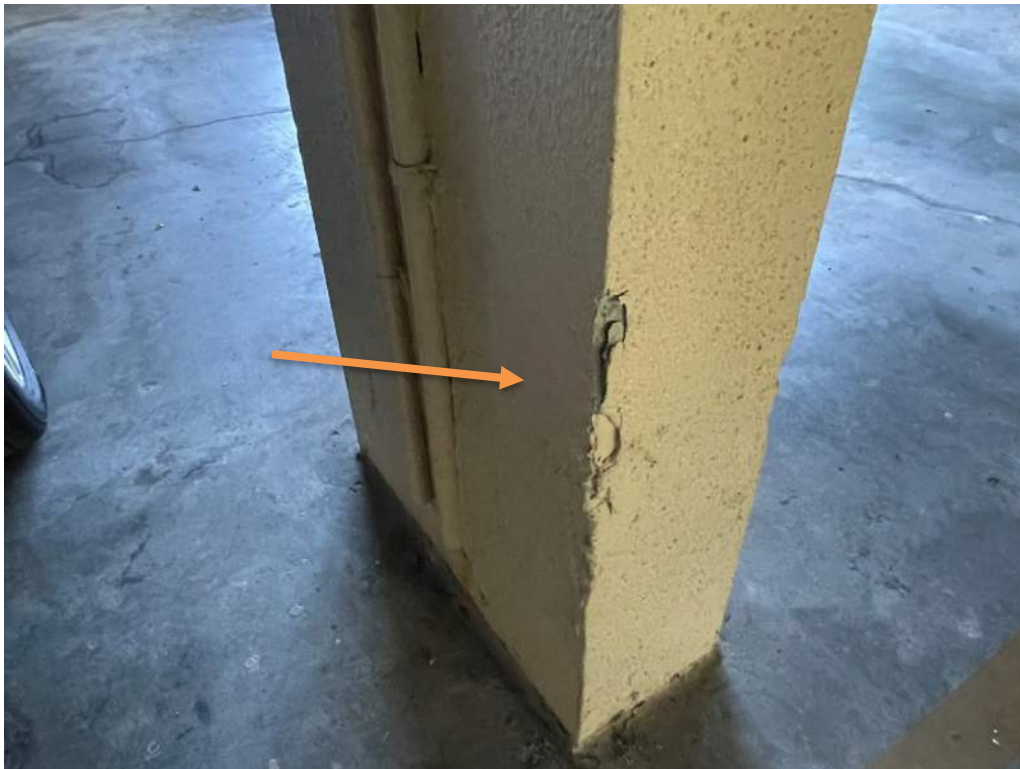
Figure 50 – Typical column damage throughout parking garage.

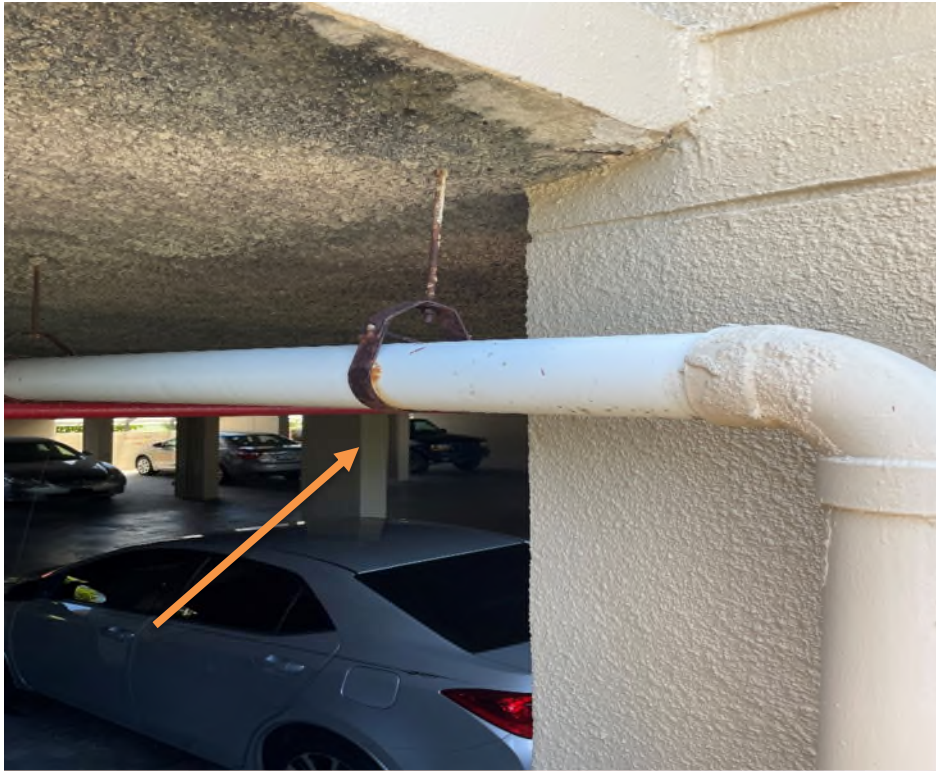
Figure 51 – Typical rusted pipe hangers, anchor bolts, and fasteners throughout parking garage.
