**PROMENADES EAST
ASSOCIATION
RESERVE STUDY UPDATE**

Report Date: July 26, 2021

**Located at:
21405 Olean Blvd
Port Charlotte, FL 33952**

**Thomas McQueen, PE
McQueen Engineering, LLC
12653 SW County Road 769
Suite A
Lake Suzy, FL 34269**

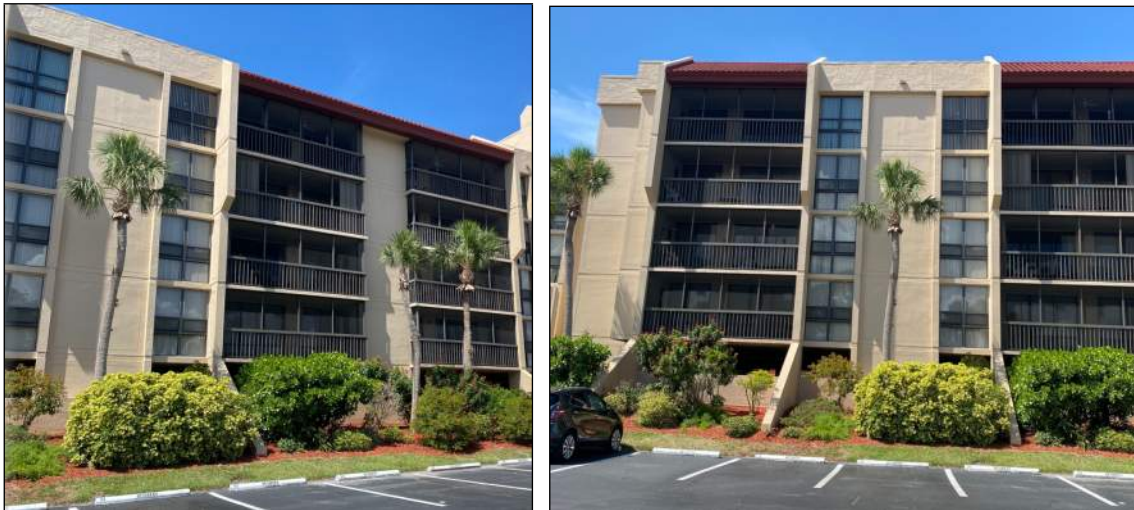
There is a single residential building containing five floors over a covered parking area at ground level. The exterior of the building is of concrete and stucco construction with individual unit balconies and screen lanais. These lanais and association screens and aluminum frames are the responsibility of the individual unit owners and, as such, are not included in this study.

The exterior paint is approximately 3 years old and shows no obvious signs of peeling or failure. In Southwest Florida, exterior paint should be applied every 7-8 years so exterior painting at Promenades East should be scheduled for 2026.

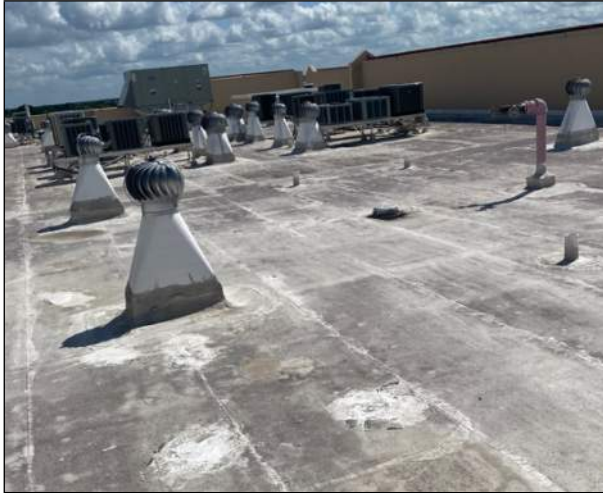
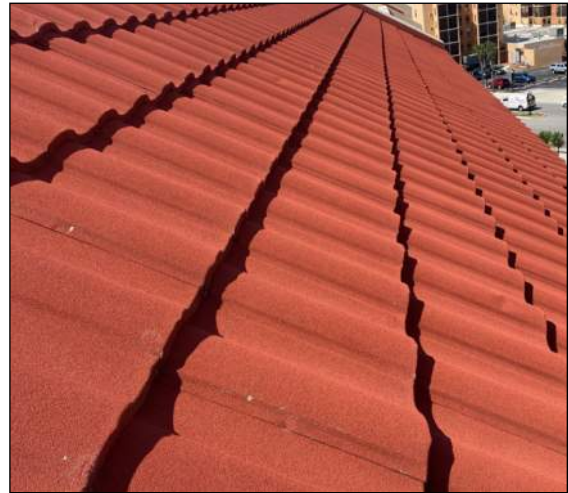
There are two separate roofing systems on the residential building. The first is an asphalt roll roofing system. This is composed of fiber and satin material rated with asphalt which it is laid in overlapping strips which are approximately 3 feet wide. The other roofing system is barrel tile which covers portions along the edge of the roof but is mostly decorative.

Roll roofing has a useful life of approximately 20 years in Southwest Florida while tile portions have a useful life of 25 to 30 years. Both have been combined in this study at the request of the association. This study creates a fund for a recoating layer of the flat roof in 4 years. Barrel tile roofing is in excellent condition and should not need replacement at the same time. There are also air conditioning systems for both the common areas as well as the individual units on the roof. Larger common area air conditions have a useful life of approximately 10-12 years and an estimated remaining life of approximately 8 years. Replacement of air conditioners for individual units is the responsibility of individual unit owners and is not included in this study.

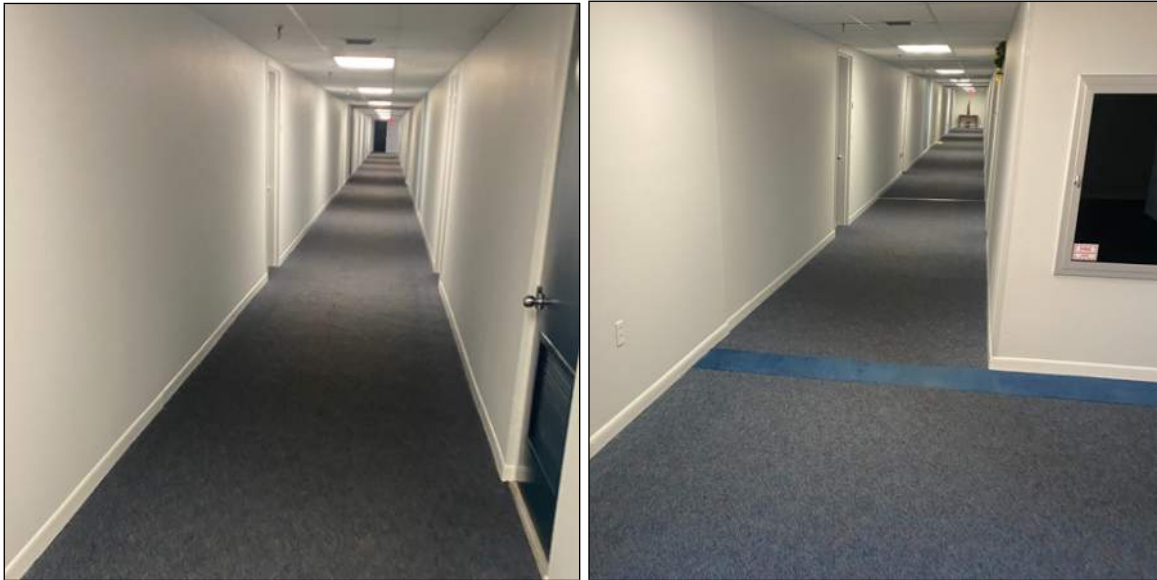
All units are accessed via common interior hallways which are painted, air conditioned and carpeted. Hallway and lobby carpeting and paint are approximately 2 years old and have useful lives of approximately 12 years.

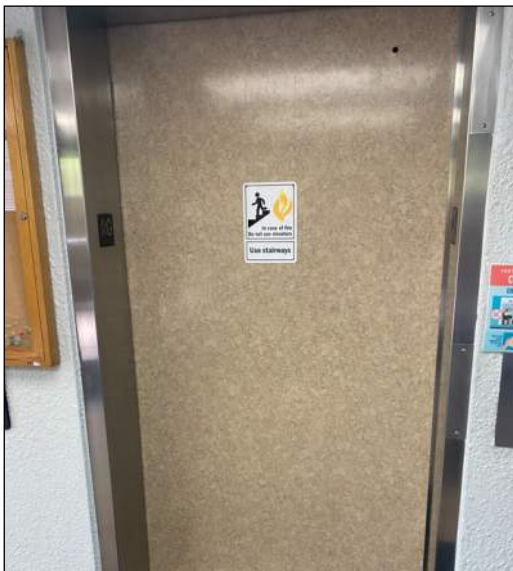
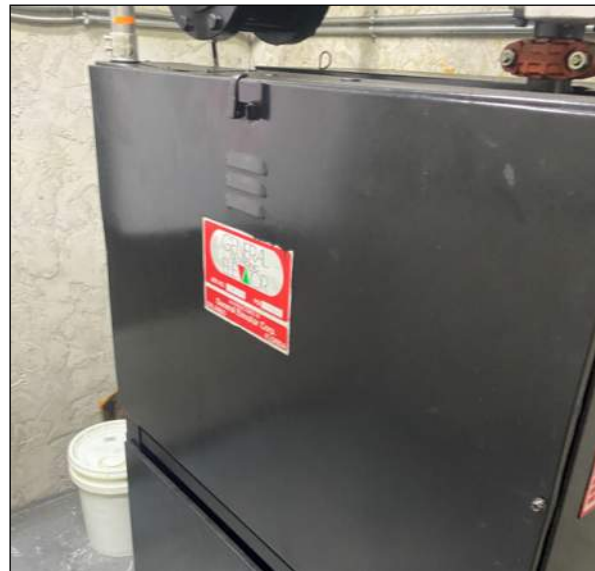
Elevator and stairs provided access to the hallways from lobbies and the parking area. The elevators are approximately 12 years old and were installed by General Elevators, Inc. Elevator cabs appear to have been renovated as well.

Elevators have a useful life of 20 to 25 years with proper maintenance and inspections so are not scheduled for replacement until 2034.

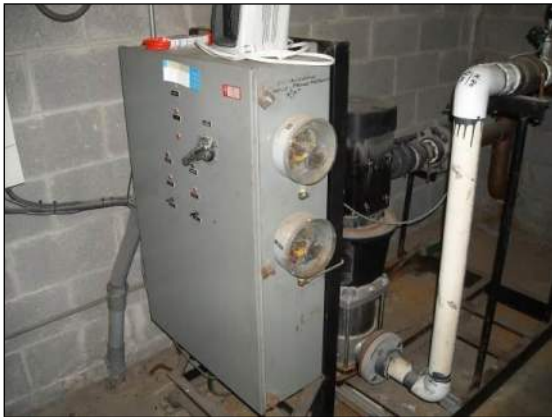
Water and sewer services are provide to each unit via common connections to Charlotte County utilities. These systems have comparable useful lives to that of the building structure and, as such, are not included in this study. Small repairs to common piping should be made as needed from the operations budget. Water pressure is supplemented by a water pump located on the ground floor. The replacement cost of this pump is relatively low and should come from the operations budget.

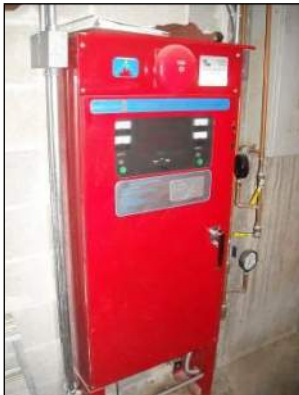
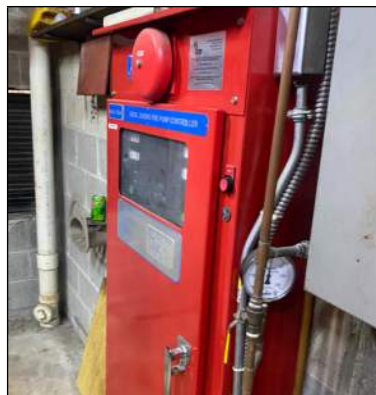
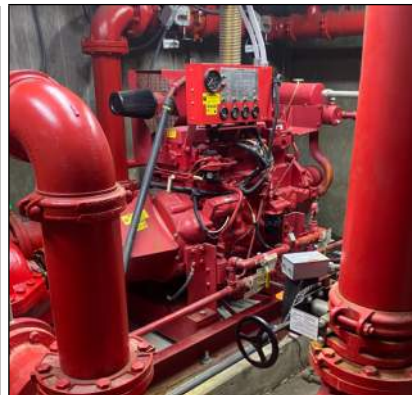
Fire suppression system consists of a simplex 4100U fire alarm panel and a building wide sprinkler system. A fire pump and diesel engine provide the necessary water pressure to the sprinklers in the event of a fire. The fire panel and pump have useful lives of approximately 25 years and are scheduled for replaced in 11 years. These systems should be tested and serviced regularly but licensed technicians to ensure that they are performing appropriately and reach their full useful lives.

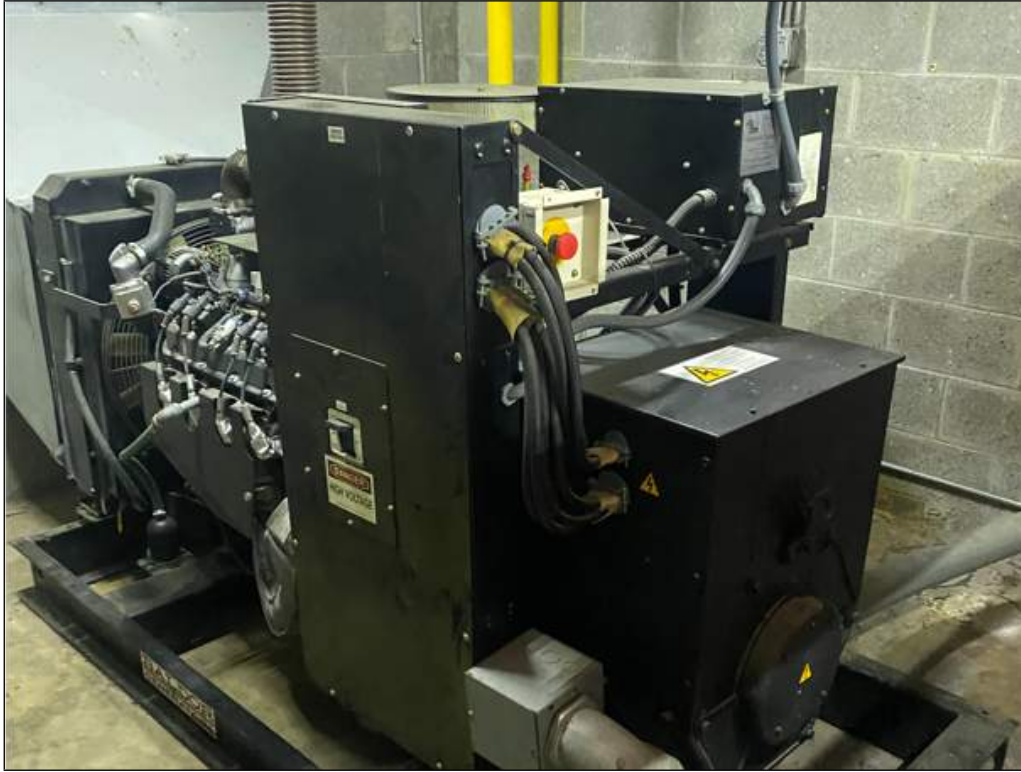
Finally, the building is also equipped with a backup generator designed to provide emergency electricity in the event of a power failure. The Baldor generator is also diesel powered and has a useful life of 25 years requiring replacement in 11 years. As with the fire pump assembly, the generator should be tested and serviced regularly by a licensed technician to ensure optimal performance and life span.

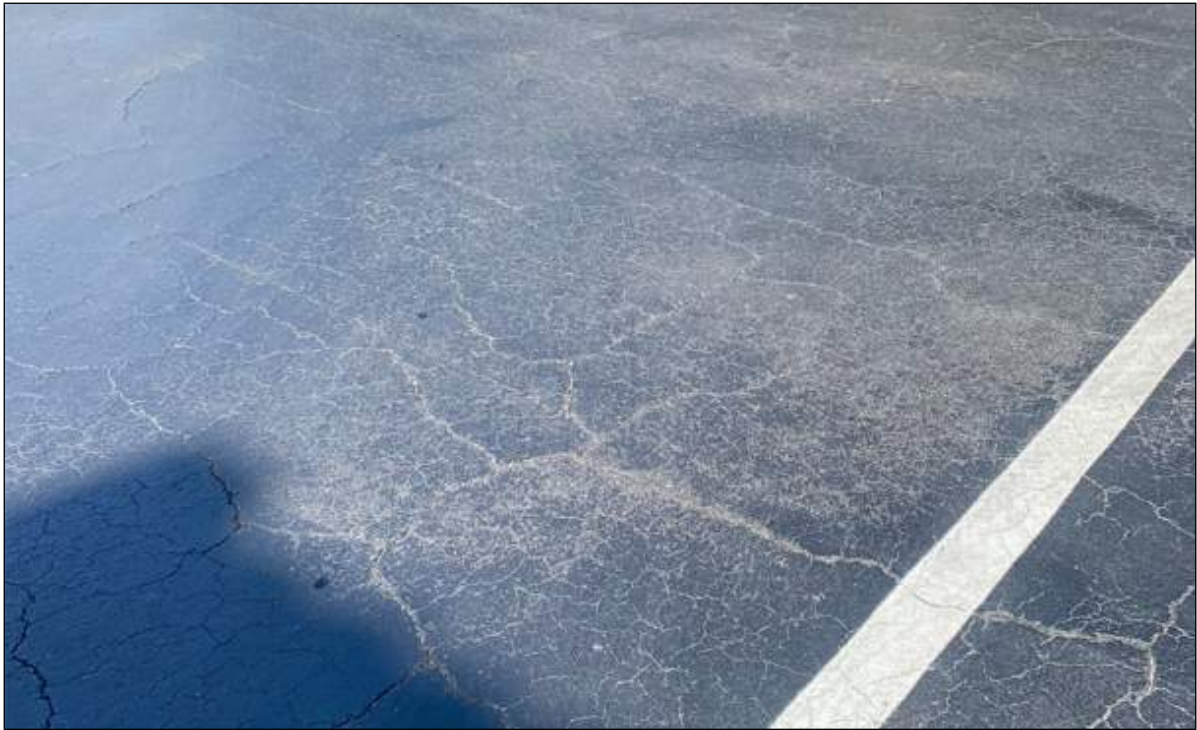
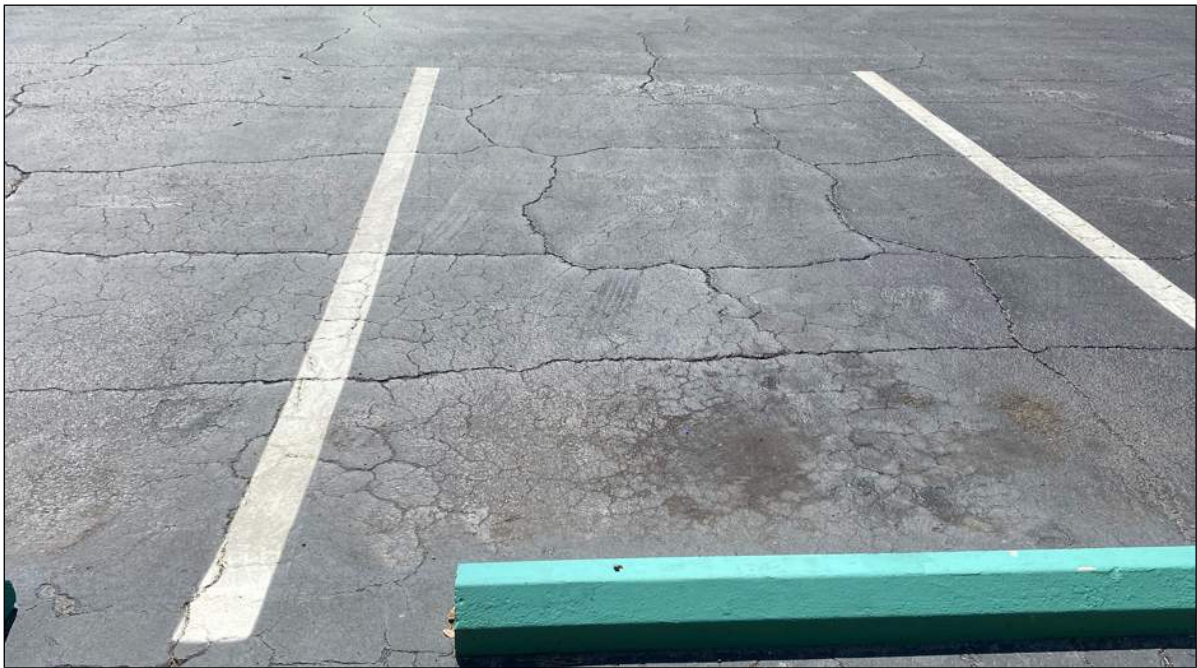
The Promenades association is responsible for the maintenance and replacement of the asphalt parking lot and concrete parking areas within the development. The asphalt parking area is approximately 5500 square yards and is comprised of approximately 1.5" of asphalt over a concrete slurry mix. Per the association, seal coats are applied regularly.

Asphalt over a base course of crushed stone has a useful life of approximately 20 to 25 years in southwest Florida. Promenades East has asphalt over a base course comprised of a concrete slurry. This type of base course provides much more stability for the asphalt and is much less prone to erosion from water seepage

through and around the asphalt. The asphalt at Promenades East has significant cracking. This cracking, while not a problem for the structural base, will continue to worsen. At some point in the future, the asphalt will need to be replaced as portions of the asphalt break free. At this point, there is no way to determine when that will be necessary so the association has elected not to reserve for a new asphalt surface coat, only regular seal coats.

Seal coating is a protective layer designed to prevent premature asphalt degradation due to sun and automotive oil exposure. Seal coating does not structurally reinforce the road nor is it a substitute for new pavement.

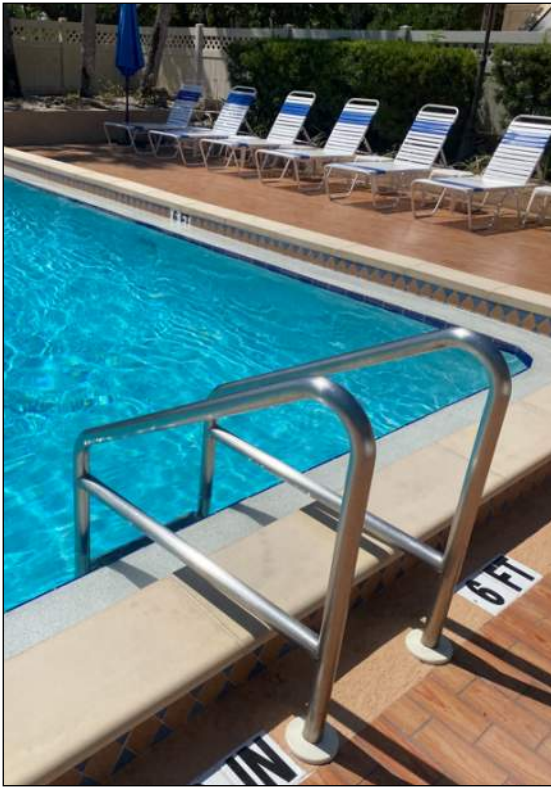
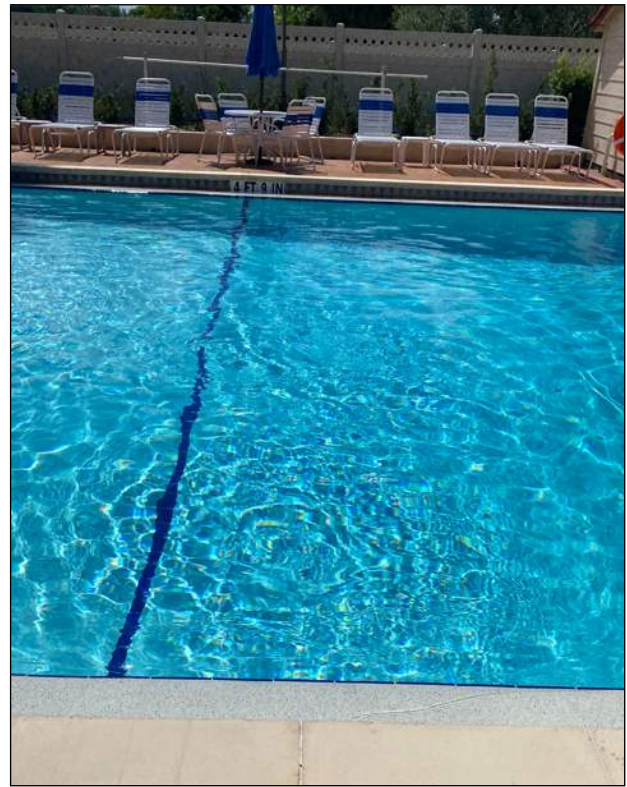
The pool deck appears to be a concrete slab with rectangular tile applied to the surface. The concrete and tile appear to be in good condition with no surface cracking or other visible degradation. While structurally, the tiles should have an effective useful life which exceeds the scope of this study, they may require replacement sooner to maintain the pool aesthetic. The association has elected not to include replacement of the pool deck tiles as a reserve item.

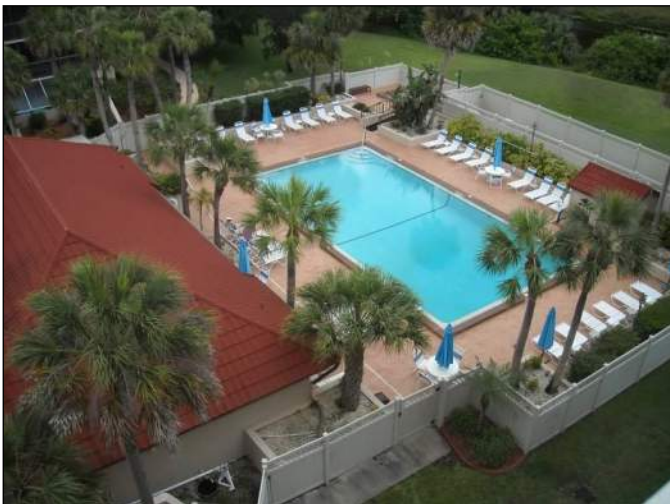
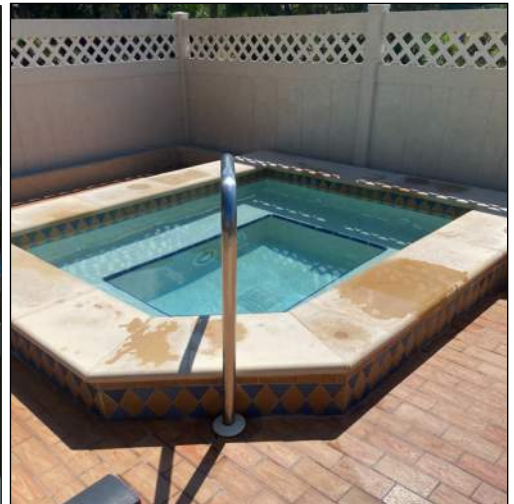
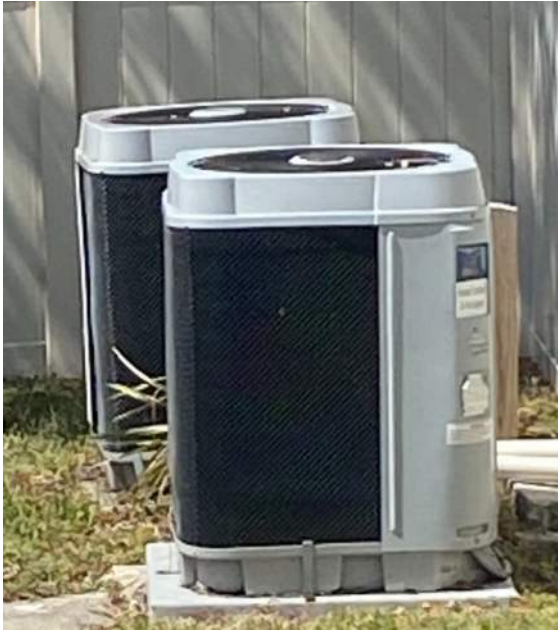
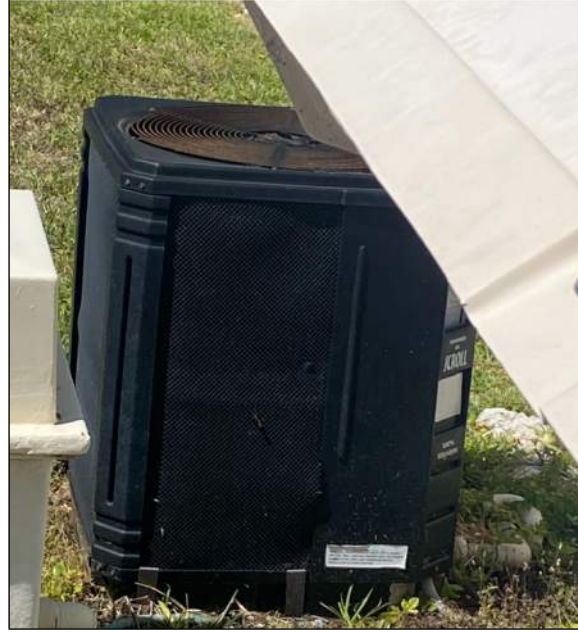
The pool is a 25 foot by 50 foot rectangle pool and the hot tub has a five person capacity. Both have a marcite coating that is was resurfaced in 2019. The effective useful life of pool surfaces in southwest Florida is approximately 10-12 years so resurfacing is scheduled in approximately 9 years. This work will include the repair and replacement of any tile along the pools edge that is worn or damaged.

The pool equipment consists of two heaters for the pool and spa as well as associated pumps, chlorination equipment and filters. The heaters are 7 years old and have an effective useful life of approximately 8-9 years. Pumps and filters have a relatively low replacement cost and should be handled from the operations budget. Pipes and chlorination containers should be replaced as needed, also from the operations budget.

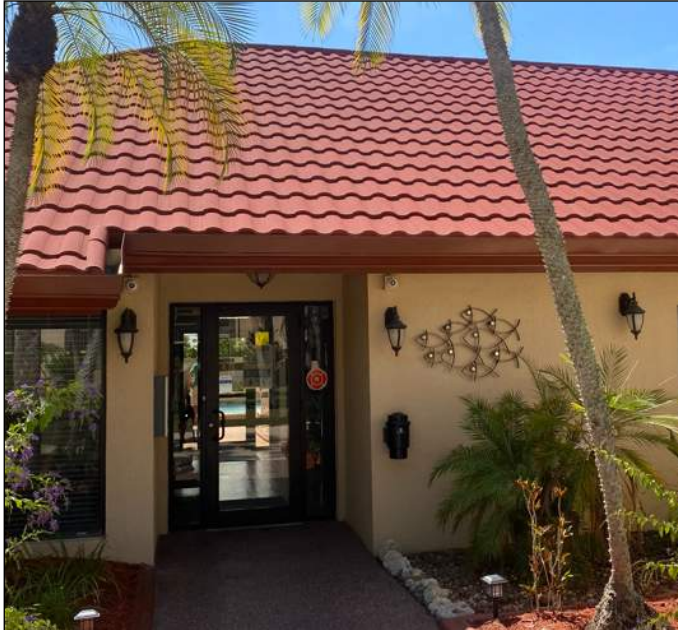
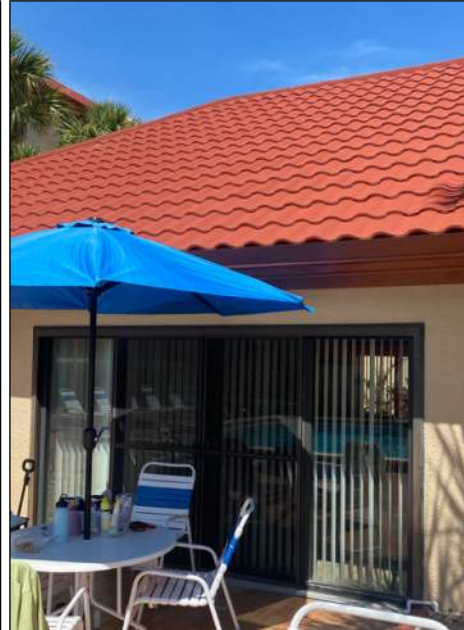
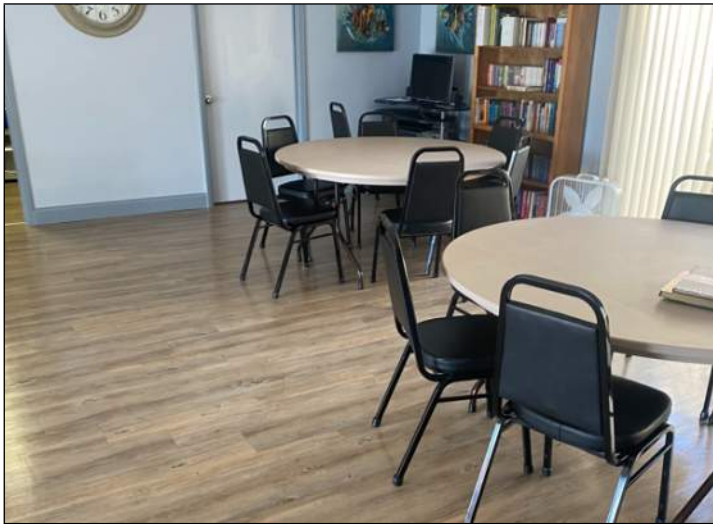
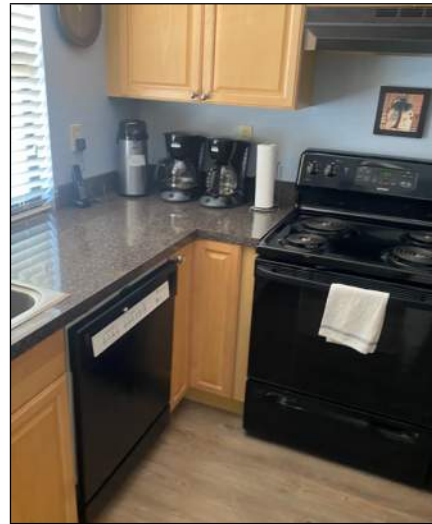
The Clubhouse is a 2200 square foot concrete block and stucco building with a barrel tile roof. The roof has an effective age of 13 years and a useful life of 25 to 30 years however its replacement cost is included with the residential roof replacement. Exterior painting is scheduled for 5 years. The clubhouse air conditioner is a smaller unit with a lower replacement cost than the residential building common area air conditioners. As such, its replacement can be funded from the operations budget as necessary.

The interior consists of an office for the management personnel, showers and bathrooms, and a common room containing tables, chairs a television area and full kitchen. The association has elected not to include any reserve items for the interior portions of the clubhouse.
